# Interim Asset Management Strategy: Arva Pumping Station to Huron Street Water Transmission Main Municipal Class Environmental Assessment Master Plan London, Ontario

**Date:** October 2020

**Project #:** 60619503

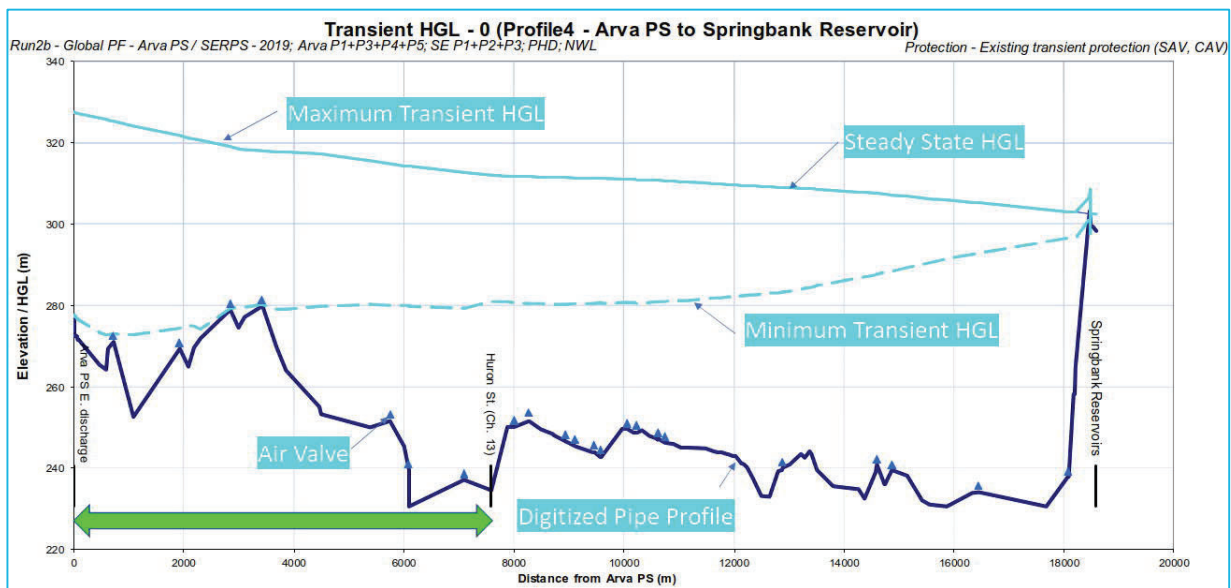
Figure 6: Transient Simulation of Existing Pipe

The pipe considered in this assignment is represented by the green arrow starting from 0 m at Arva Pumping Station to Chamber 13 at approximately 7.5 km to the pumping station. Based on the elevation of the pipe and the maximum Transient HGL head, the overall maximum HGL is the greatest between Windermere Road and Huron Street. The maximum working and surge pressure (internal pressure) is observed at approximately 6 km from Arva Pumping Station. At this point, the difference between the elevation of the pipe and the Maximum Transient HGL is the highest. The elevation of the pipe at this location is approximately 230 m and the HGL head is 314 m. Based on these elevations, the pressure head would be 84 m, which corresponds to 119 psi. This location is closest to Windermere Road in the section running between Windermere Road to Huron Street. Overall, the minimum HGL that is simulated does not vary much along the same pipe. The minimum HGL along the same segment ranges between (46 m [65 psi], and 50 m [70 psi]).

From the historical data received, the observed breaks are mostly recorded along the same section where the highest maximum transient HGL is recorded.

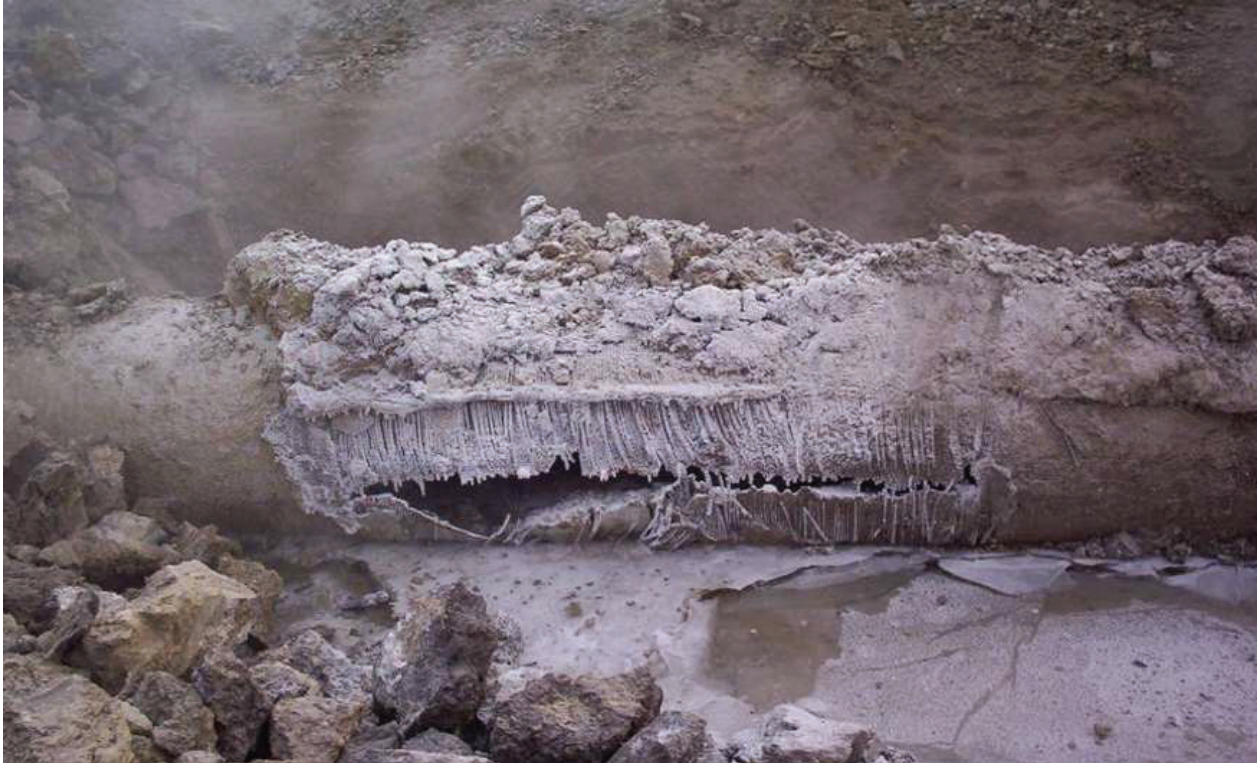
Failure of the pipe barrel is the most catastrophic form of failure. The root cause of barrel failures is prestressing wire corrosion, which occurs when multiple wires corrode to failure and create broken wire zones (BWZ's) along the pipe. When BWZ's become too large, there is a loss of compression in the concrete core of the pipe, which leads to catastrophic failure. Failures of this nature are usually sudden and lead to a large loss of water in a short period of time. A well-documented failure of this nature (full barrel rupture due to excessive BWZ's) occurred in Calgary, AB in 2004 (see Figure 4). This is by far the most serious failure mode and inevitably result in very high direct costs for repair and high consequential damage costs.

In water service, the most common cause of prestressing wire corrosion is a breakdown of the exterior mortar coating due to poor quality control in original manufacture, a bad match of exterior mortar properties and the external exposure environment, or some combination of the two. The high wrapping stresses of PCCP wire are particularly vulnerable to accelerated corrosion as they facilitate stress corrosion cells. As corrosion product develops, it promotes a breakdown of the exterior mortar coating which facilitate further corrosion and an increase BWZ area.

**Figure 4: PCCP Barrel Failure - McKnight Blvd and Resultant Loss of Water, Calgary, AB**

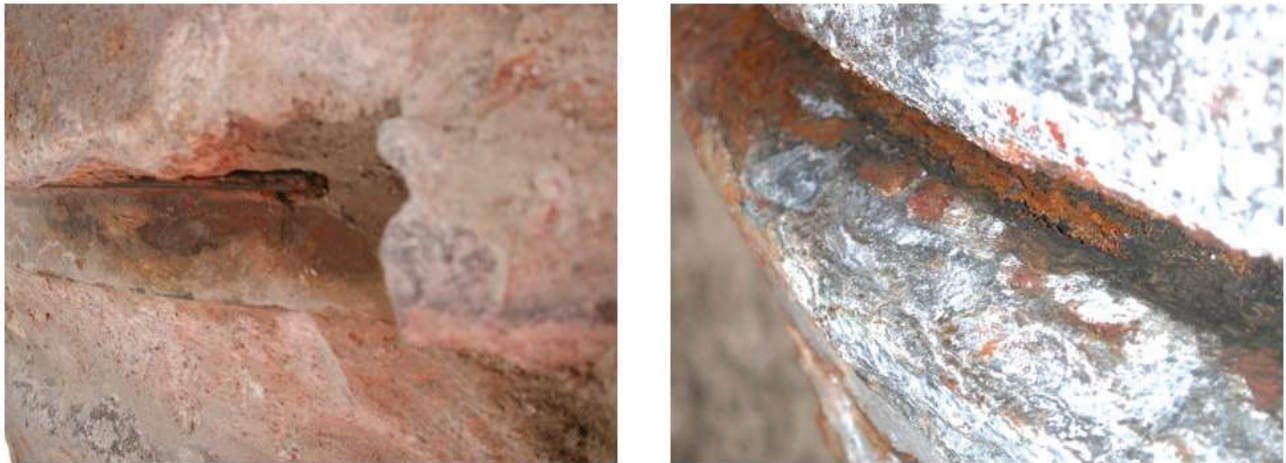
Previous investigations by AECOM in Luck Lake, SK (2006-2010) examined and rehabilitated numerous joint related failures on approximately 160 km of PCCP installations. In Luck Lake, the soil chemistry had very high sulphate levels, a fluctuating groundwater table and a mortar grout that was preferentially broken down at the joints due to the external exposure environment and improper grout selection for the exposure conditions. These progressive failures at the joint provided considerable insight into how the corrosion process is advanced once the steel joint rings are exposed to the environment. A typical failure is depicted in Figure 5.

**Figure 5: Failed PCCP Joint in Luck Lake, SK**

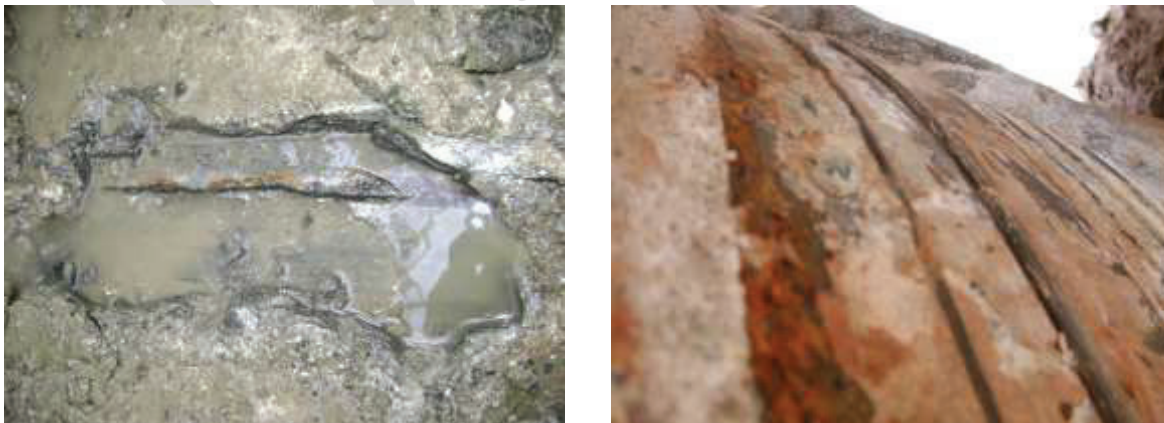
In Luck Lake, all joint leaks appeared prior to having extreme BWZ's open up on the pipe. The significance of this is that the failures, while costly and with some consequential damage, never progressed to the stage of a PCCP barrel failure which is a far more catastrophic mode of pipe failure that releases a much larger volume of water upon failure.

**Figure 6: Luck Lake, SK - Progression of Joint Deterioration to Prestressing Wires**

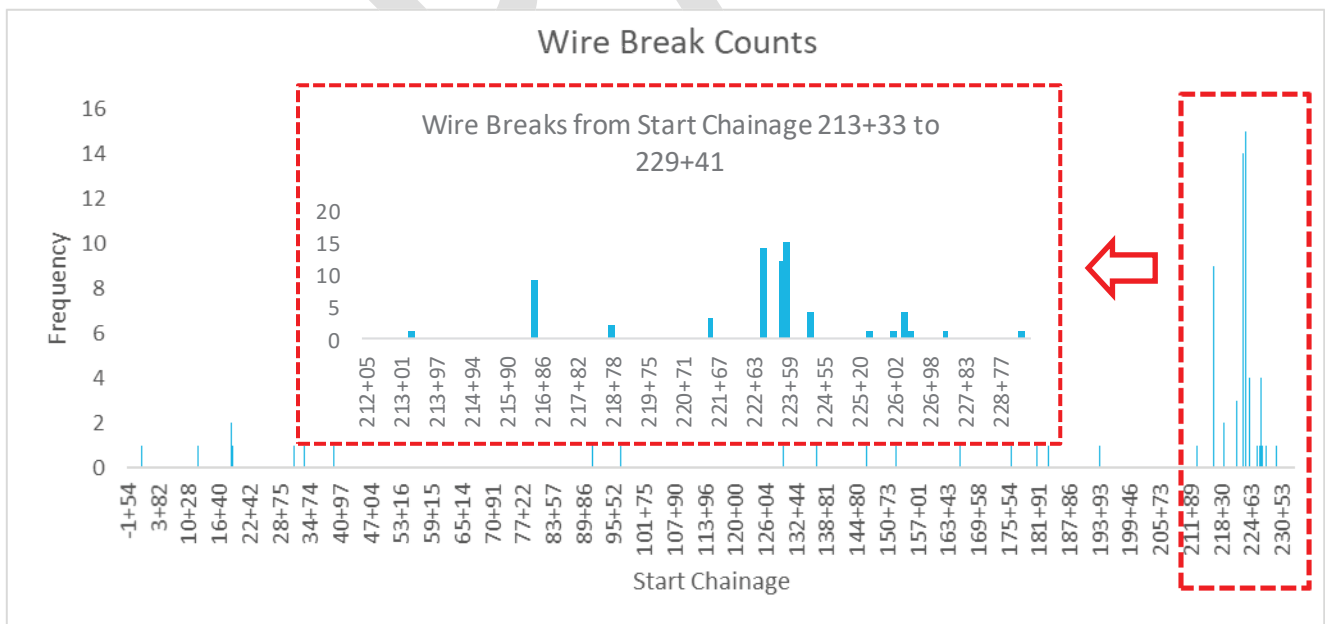
The information from AFO and EM inspections were integrated in Figure 9. The y-axis represents the wire break frequency and the x-axis denotes the start chainage of each Pipe ID. The figure suggests that 14 pipes with reported wire breaks are located from Start Chainage 213+33 to 229+41, in which 9 distressed pipes are within 500 m (Start Chainage 222+95 to 227+34). This figure excludes Pipe# 1490 and 1492 as it is expected that these pipes were replaced once they were removed for validation.

Figure 9: Wire Break Frequency – Acoustic and EM

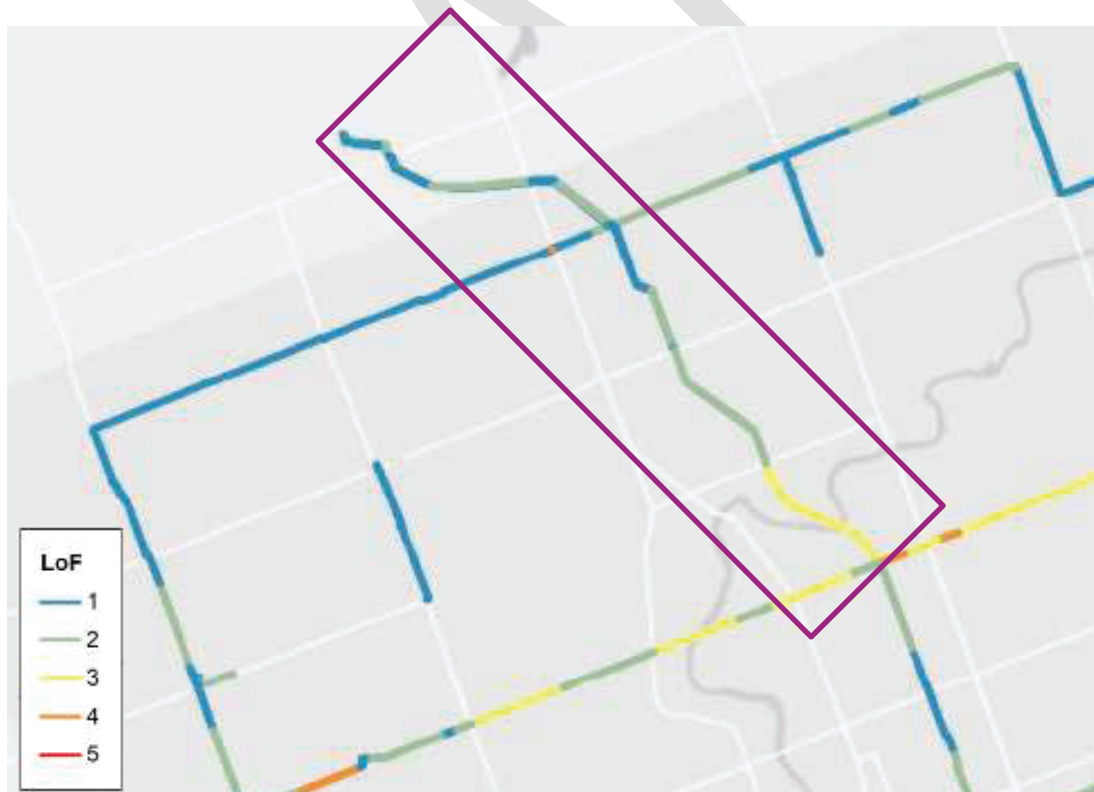
Based on Pure's methodology, the representative LoF map is shown in Figure 11. The LoF of Pipes from Arva Pumping Station to Windermere Road ranged between Very Good (RUL is greater than 60 years) to Good (RUL is between 40 to 60 years) and the segment located to the south of Windermere Road to Huron Street is ranked as Adequate (RUL is between 20 and 40 years).

Figure 11: LoF Map

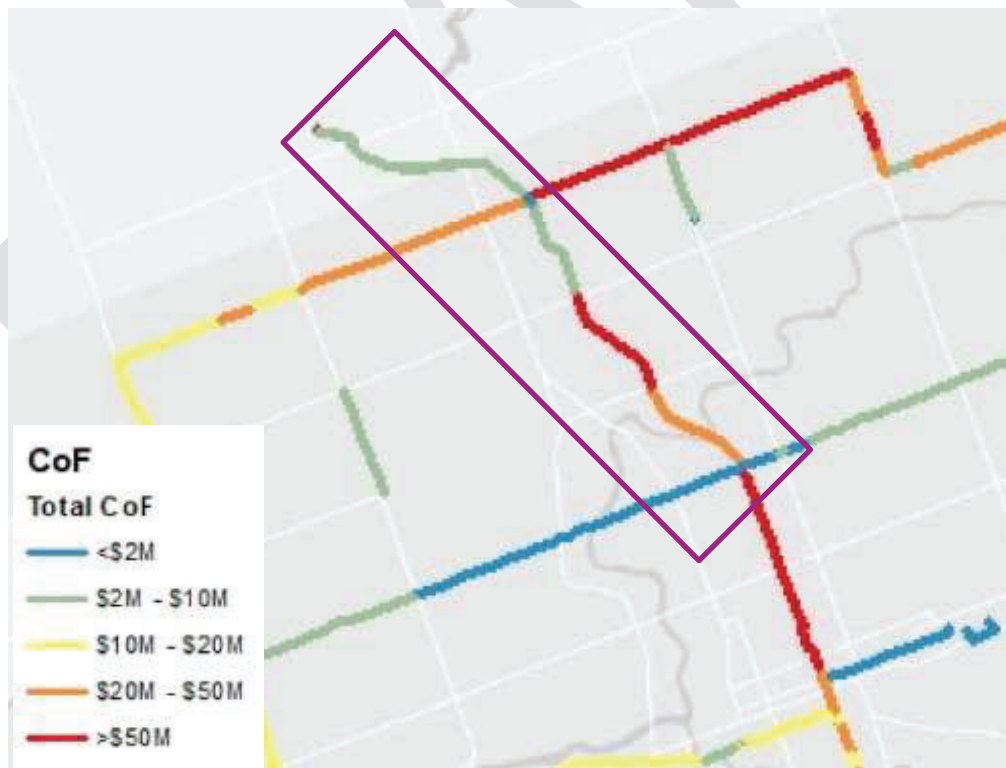
Based on the aforementioned factors and subfactors, the consequence model generated the results shown in Figure 12. As per the figure, the CoF for pipelines stretching from Arva Pumping Station to Huron Street were between less than \$2 M and greater than \$50 M. None of the sections along this stretch were between \$10 M and \$20 M. From the visual representation, slightly more than half of these transmission mains' CoF was in the \$2 M and \$10 M.

Figure 12: CoF Map
