**Preliminary Slope  
Assessment - Beaverbrook  
Community, 323 Oxford  
Street West and 92 & 825  
Proudfoot Lane, London,  
Ontario**

2303401

Sam Katz Developments Limited

June 30, 2023

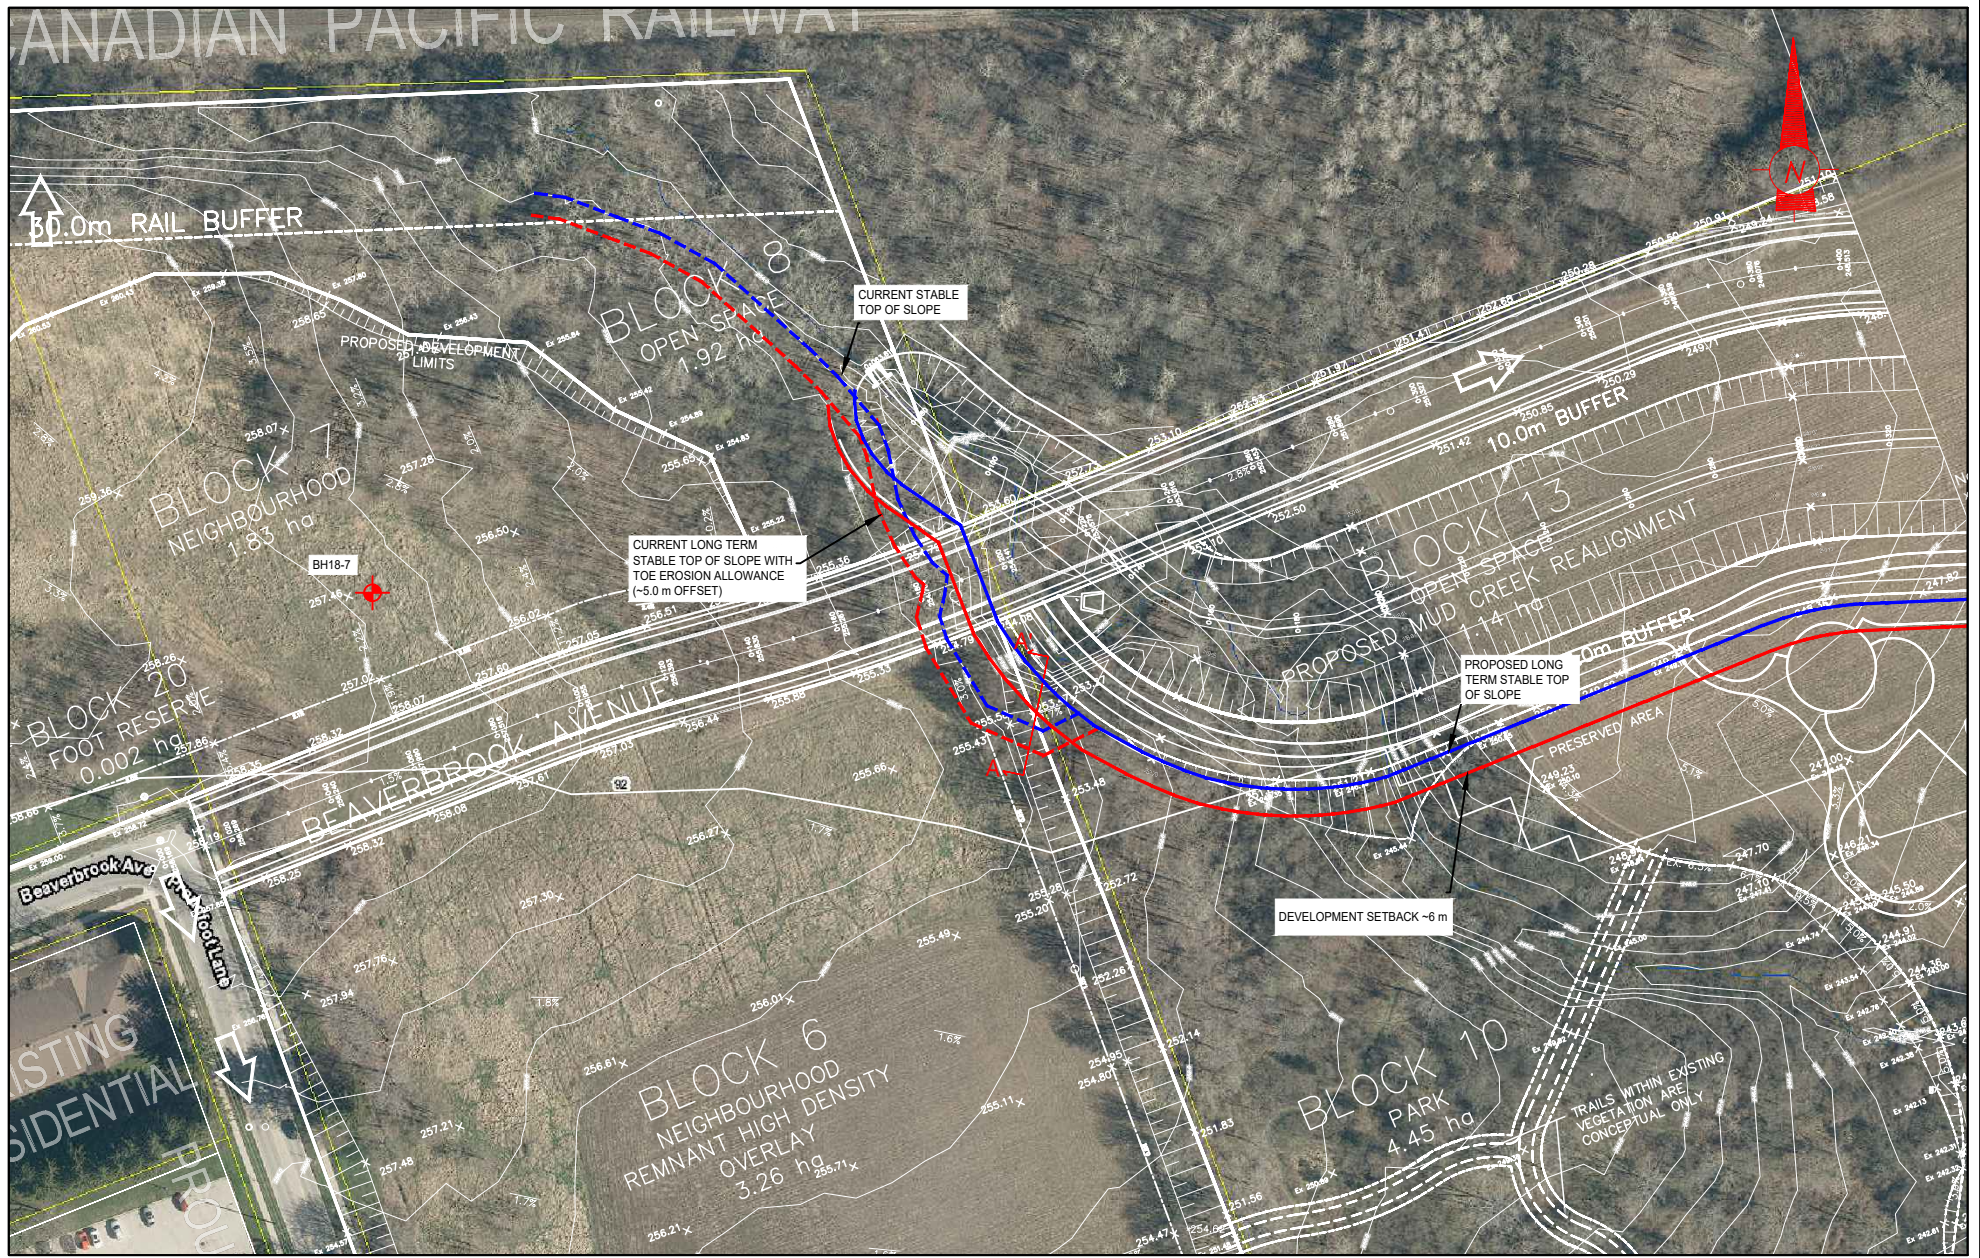
The Long-Term Stable Top of Slope (LTSTOS) is estimated in accordance with the UTRCA and Section 3.1.1.1 of the MNR Technical Guide. A toe erosion setback of 5 m and a minimum slope angle of 3H:1V was applied to section A. The results shown on **Drawing 1** show the LTSTOS at section A is setback about 8.0 m from the current physical top of slope. To determine the LTSTOS along any section of the tributary of the Thames River on the site, the 5 m toe erosion allowance and a 3H:1V slope angle from the toe of the slope was applied. The resulting red line seen in **Drawing 1** indicates the setback of the LTSTOS including the 5 m toe erosion allowance.

While this setback line does not encroach upon the planned development area for Block 7, it may encroach upon the planned development area for Block 6.

However, it should be noted that there are plans to reroute the tributary along with channel widening that will reduce the final slope angle to an average of 5H:1V. Since the results of this assessment has determined that an existing slope of 3H:1V is considered stable, the final, more shallow slope face of the planned reroute is also considered stable. This can be applied to any further planned earthworks in Blocks 6, 7 and 10, slopes will be stable as long as angles are at least 3H:1V or shallower. Both the proposed LTSTOS and development setback of the planned channel widening can be seen in **Drawing 1**.

Palmer considers this as a desktop study for planning level analysis. It should be noted that this LTSTOS limit does not include the additional development setbacks which will be specified by the UTRCA and will determine the limit of development on the property. The typical value of 6 m has been applied in **Drawing 1** for visual purposes only.

To maintain slope stability of proposed slopes, construction should include a vegetation cover upon the slope face to aid with erosion protection.

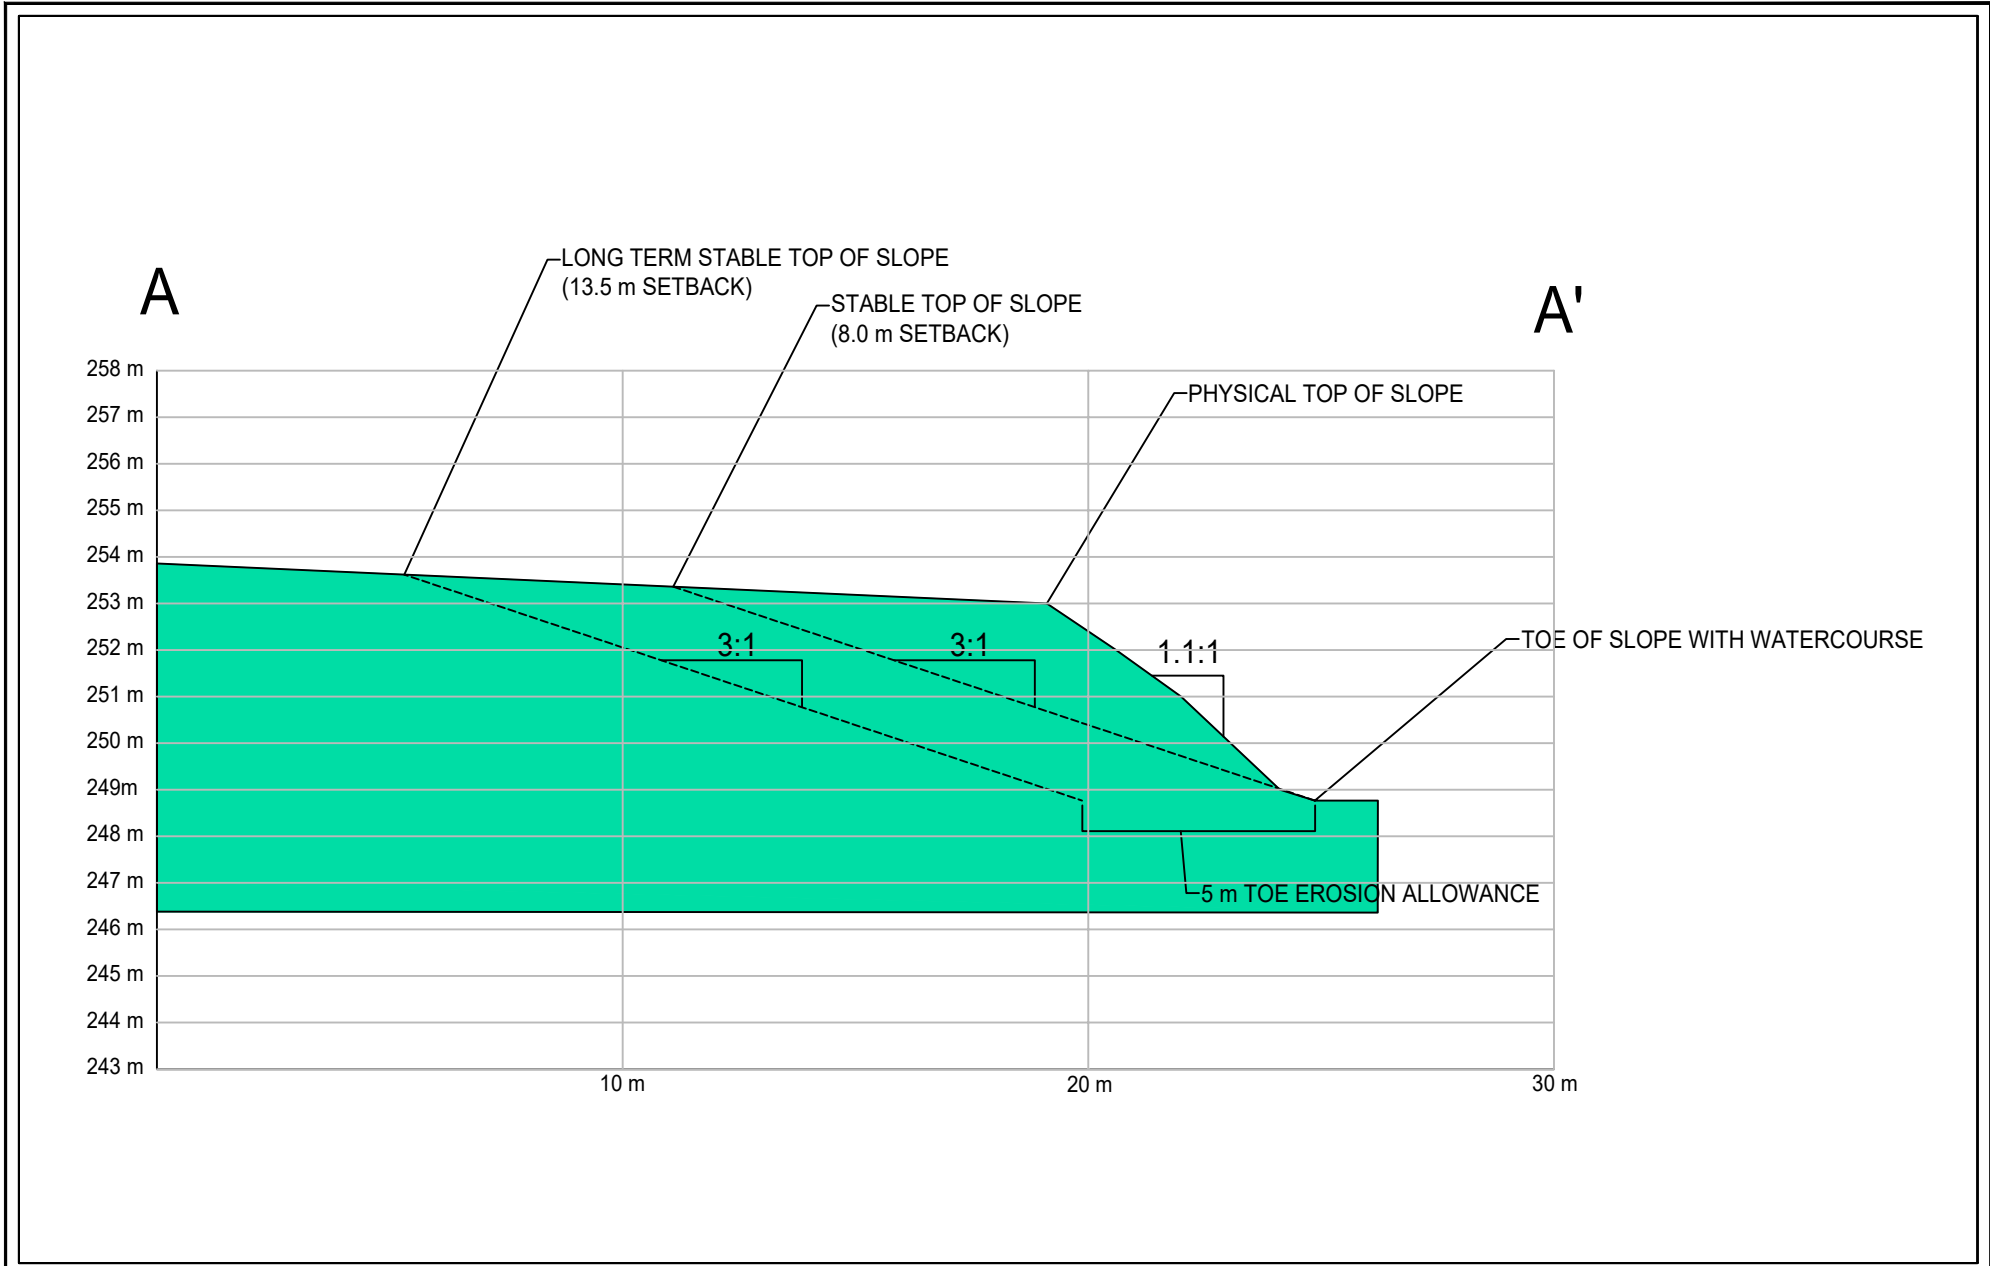
Section A-A' mentioned on **Drawing 1** and seen in **Figure 2** is shown as a representation of the critical slope section from Palmer's slope reconnaissance. Soil stratigraphy is assumed from Palmer's preliminary geotechnical investigation (2018).

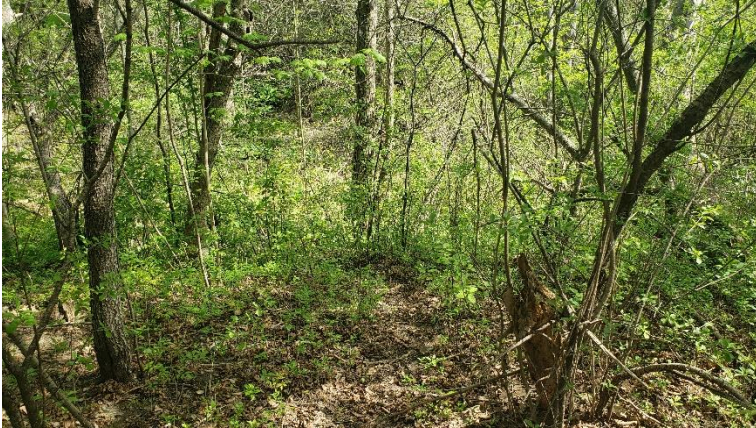
*Photograph 1*

- Vegetation on the slope was moderate to dense consisting of mature trees and bushes (**Photograph 1 and 2**);
- Evidence of table land drainage was observed near the toe;

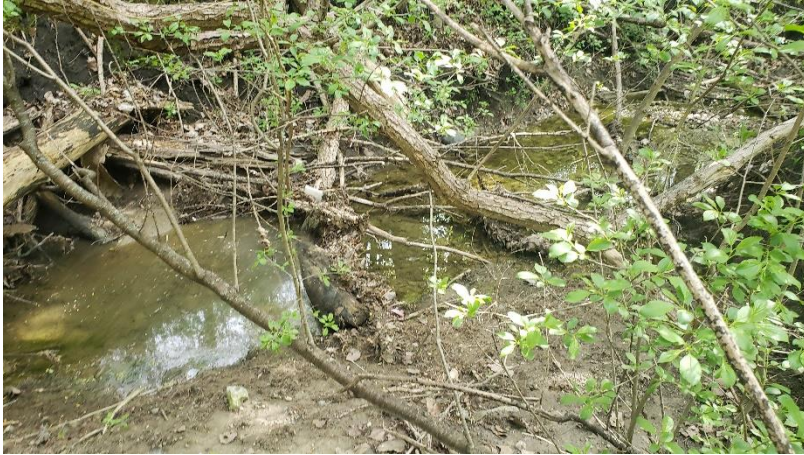
*Photograph 3*

- No evidence of deep-seated instability was observed;
- No evidence of seepage coming from the slope face was observed;
- Active erosion was observed at the creek bed directly at the toe of the slope with fallen trees and slumps into the creek (**Photograph 3 and 4**);

- Damage to the existing slope must be kept to a minimum and deep-rooted vegetation should be introduced to the slope face and surrounding areas to reduce surface erosion.
