**1467 Wharncliffe Road South, London,
Ontario, Arborist Report**

June 17, 2022

161414191

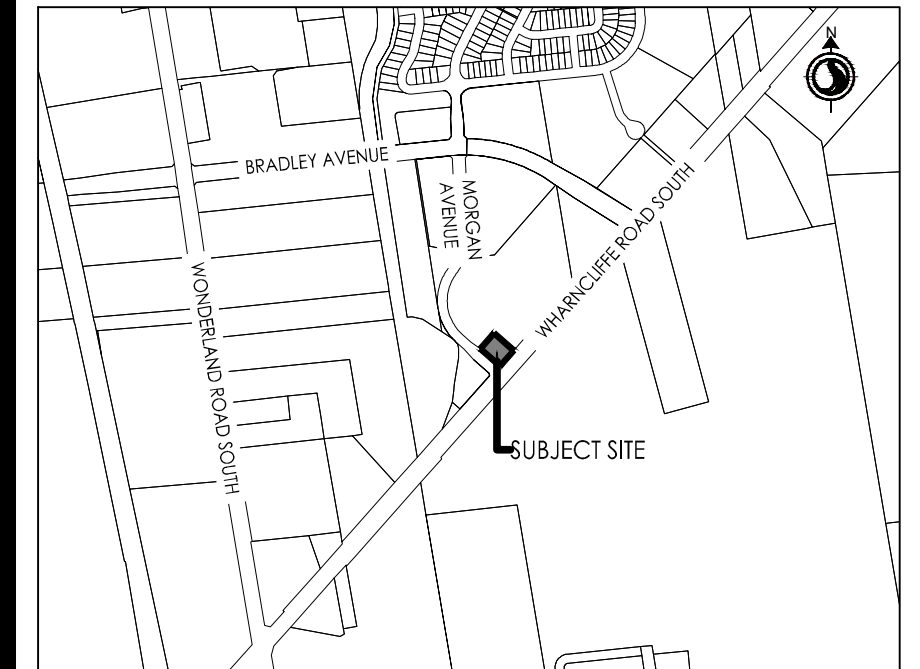
L-900

Two (2) trees (#15, #21), cedar hedge unit #1 and the north portion of cedar hedge unit #3 within the Site are recommended to be preserved and protected with a Tree Protection Fence (TPF) as per details on

drawing L-900. One (1) tree (#23) will have a reduced tree protection zone (TPZ), and 5 trees (#16-20) are outside of the construction limit and will not require any TPF.

There are 15 trees (#1-14, #22) and the south portion of cedar hedge unit #3 are recommended for removal as they are within the limits of the proposed building expansion as detailed on Drawing L-900.

1. Tree Preservation Hoarding shall be installed to protect trees identified for preservation. Tree Preservation Hoarding must be installed as per the detail identified on Drawing L-900. Upon installation of the Tree Preservation Hoarding, the Contractor shall contact the Environmental Inspector to review and approve the fencing and its location prior to commencement of any site work. This shall be coordinated with City staff for final approval (as required). The protection fencing shall remain intact throughout the entire project. The fencing will be inspected weekly, and if required, repaired. The fencing shall be removed at the completion of all site works.
