**3810-3814 COL TALBOT RD
LONDON, ONTARIO
TREE ASSESSMENT REPORT
FOR REZONING APPLICATION**

**PREPARED BY: RON KOUDYS LANDSCAPE
 ARCHITECTS INC**

DATE: NOVEMBER, 2021

RKLA PROJECT #: 21-260

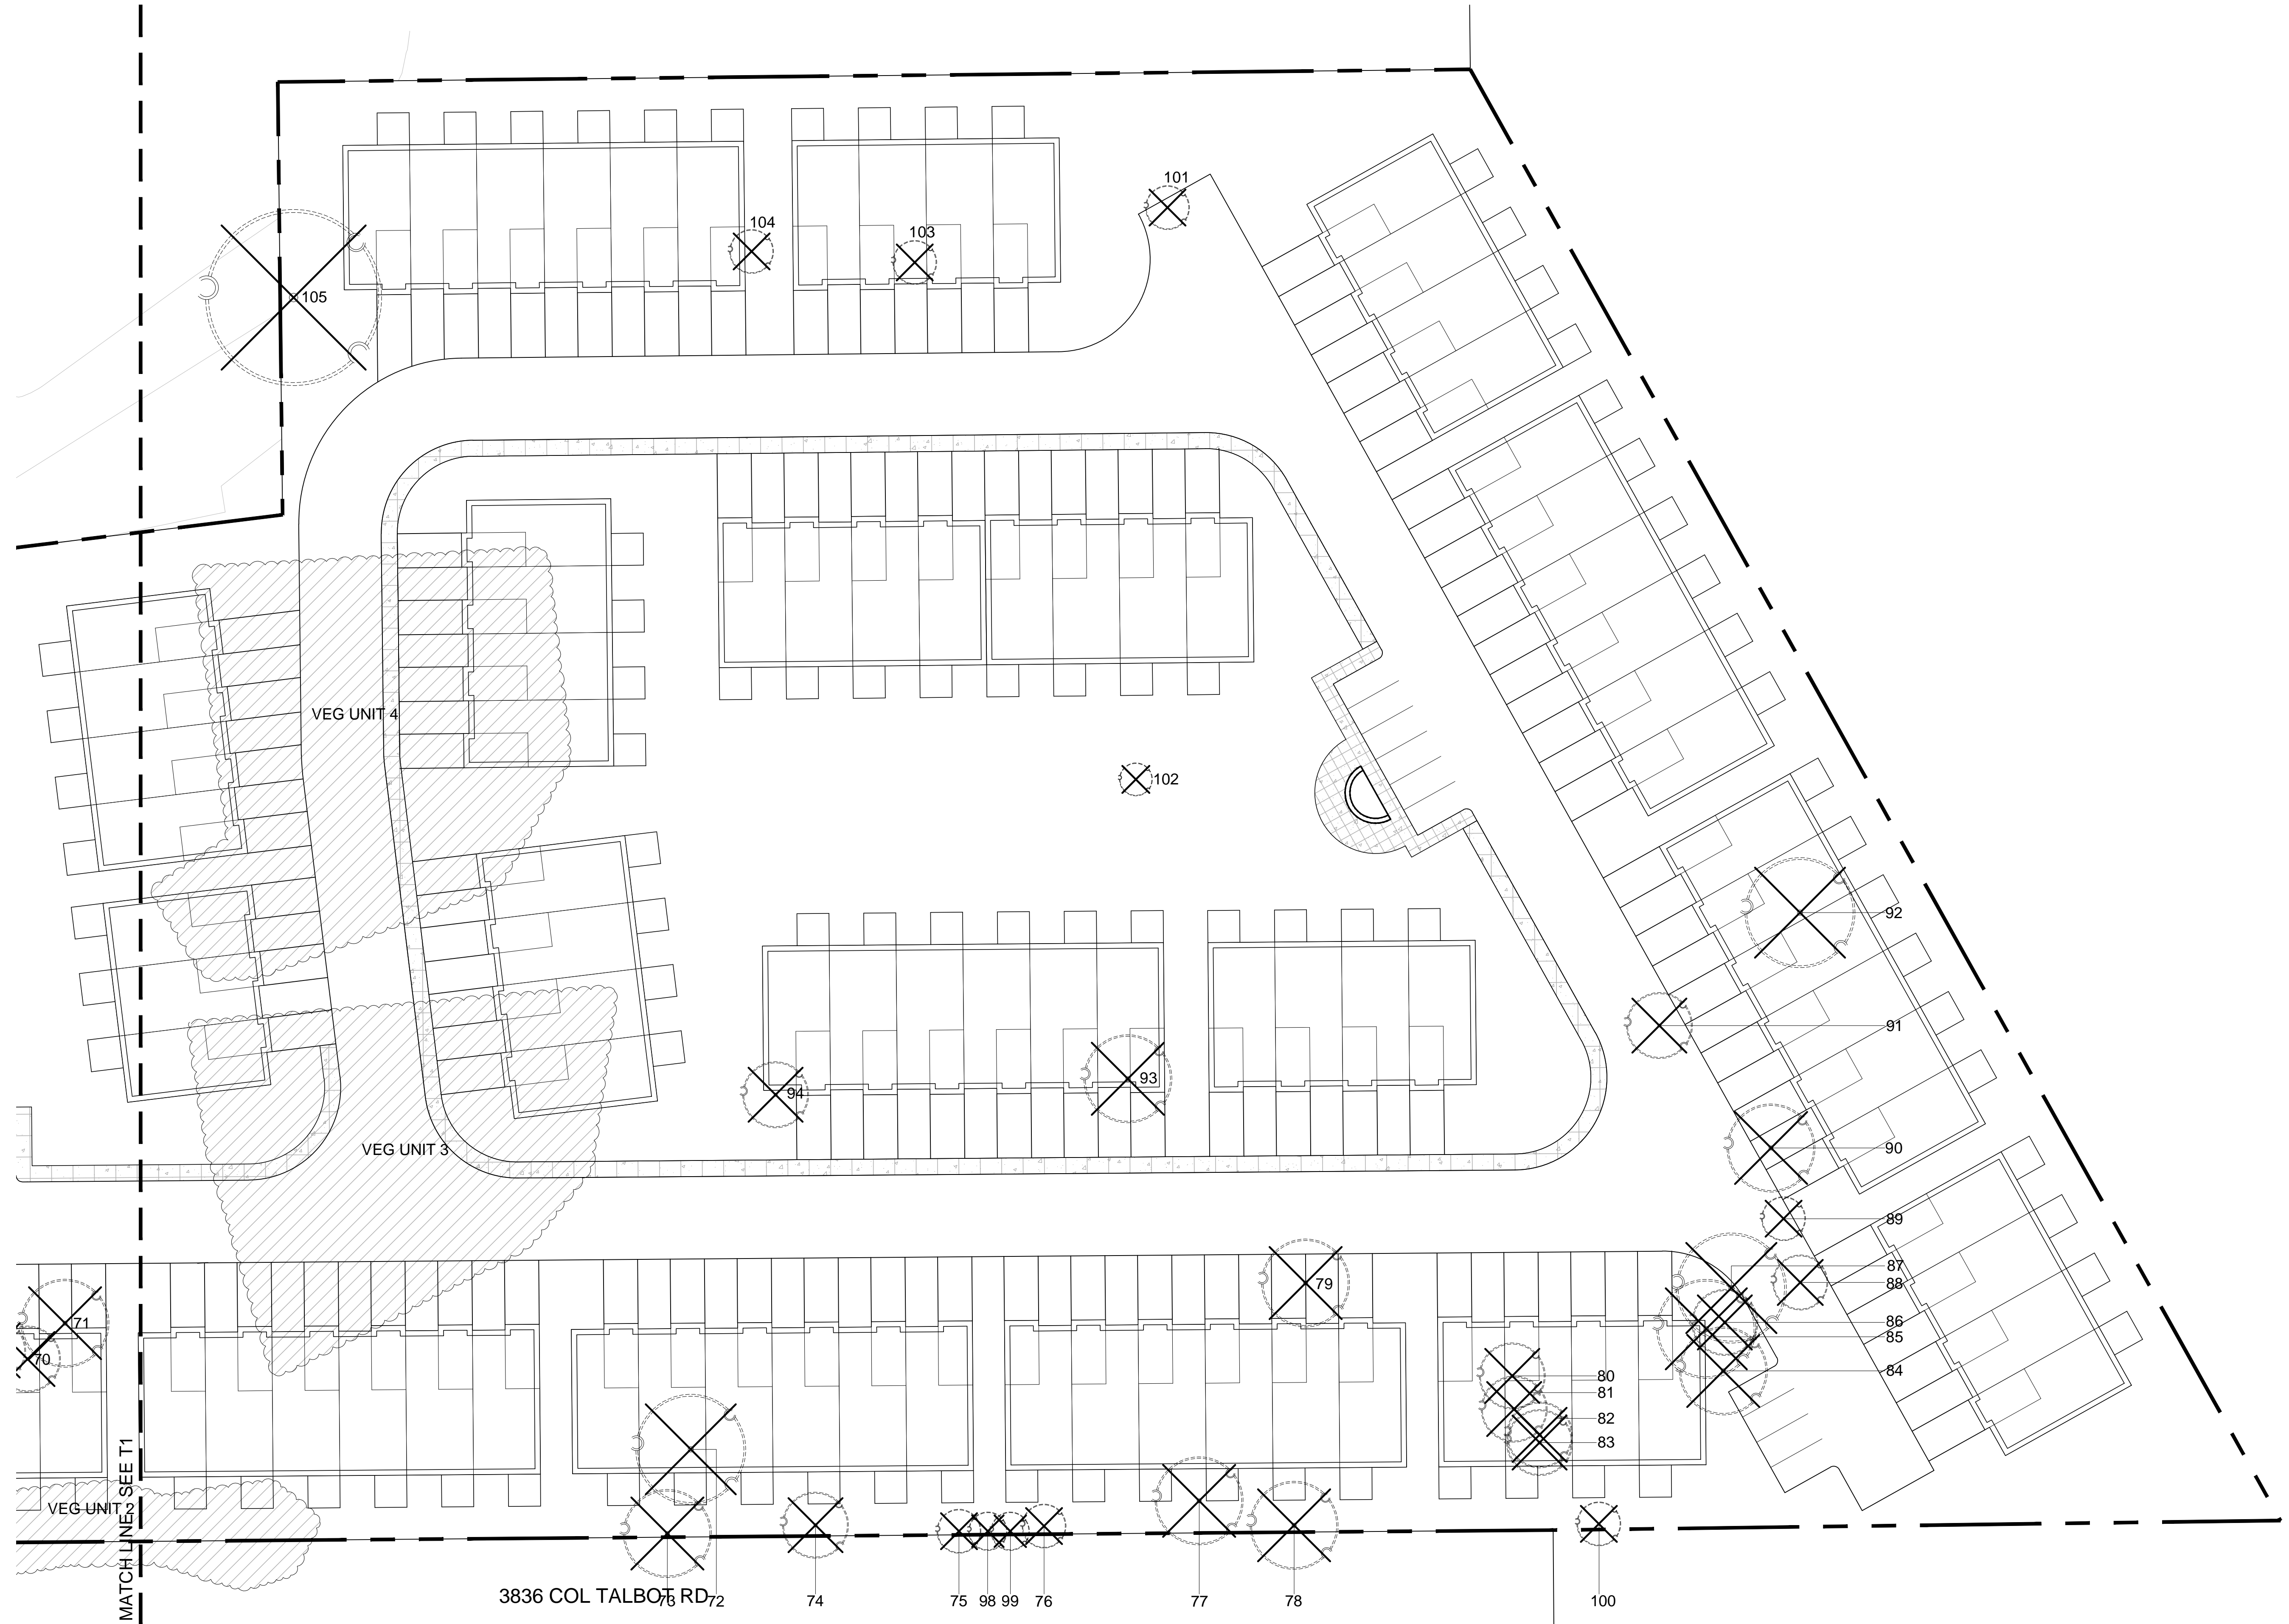
DATE: OCTOBER 2021	SCALE: AS NOTED	DRAWING No. T-2
DRAWN: RRLA Inc.	CHECKED BY: B.R.M.	
PROJECT No. 21-260Lf

TREES RECOMMENDED FOR REMOVAL (97 TREES)

55	<i>Acer spicatum</i> Manitoba Maple	Subject site	50, 47, 10	12	5	poor	Multistem 3, primary union, epicormic growth, loose crown, branched to grade, trunks at 6 and 90 degrees	Direct conflict with proposed construction	remove	none
56	<i>Malus sp.</i> Malus	Subject site	25, 27, 26, 26, 29	6	5	fair	Multistem 3, primary union at grade, reduced bark at clustered primary union	Direct conflict with proposed construction	remove	none
57	<i>Agilops nigra</i> Black Walnut	Subject site	22, 21	4	4	fair	Multistem 1, tight union, primary union 1m above grade	Direct conflict with proposed construction	remove	none
58	<i>Agilops nigra</i> Black Walnut	Subject site	25, 19	4	5	good	Multistem 2, dominant leaders with reduced bark	Direct conflict with proposed construction	remove	none

78	<i>Populus deltoides</i> Cottonwood	BOUNDARY - Subject site & 3856 Col Talbot Rd	44, 26	4	5	poor	Multistem 2, at base of concrete block wall, growing and bending over wall	Direct conflict with proposed construction	remove	Consent from owner of 3856 Col Talbot Rd required
79	<i>Rubus cuneifolius</i> Black Locust	Subject site	20, 14, 15	4	5	fair	Multistem 3	Direct conflict with proposed construction	remove	none
80	<i>Populus deltoides</i> Cottonwood	Subject site	33, 32, 30	5	5	fair	Multistem 3, included bark and seam at primary union, significant trunk wound and rot at base	Direct conflict with proposed construction	remove	none
81	<i>Ulmus pumila</i> Siberian Elm	Subject site	22	3	4	poor	Cracky trunk, suppressed	Direct conflict with proposed construction	remove	none
82	<i>Acer spicatum</i> Manitoba Maple	Subject site	29	4	5	fair	low scaffold branch, epicormic growth	Direct conflict with proposed construction	remove	none

89	<i>Prunus sp.</i> Cherry	Subject site	11	2	5	good	at top of 1m tall shear drop	Direct conflict with proposed construction	remove	none
90	<i>Acer spicatum</i> Manitoba Maple	Subject site	35	4	5	fair	lean W, dense crown, columnar leaders	Direct conflict with proposed construction	remove	none
91	<i>Populus deltoides</i> Cottonwood	Subject site	33, 18	4	5	fair	Multistem 2, light crown, dead low branches	Direct conflict with proposed construction	remove	none
92	<i>Acer spicatum</i> Manitoba Maple	Subject site	24, 24, 9	5	5	fair	Multistem 3, branched to grade, low hangers	Direct conflict with proposed construction	remove	none
93	<i>Acer spicatum</i> Manitoba Maple	Subject site	26	4	4	fair	Straps, straggly form	Direct conflict with proposed construction	remove	none
94	<i>Acer spicatum</i> Manitoba Maple	Subject site	22, 10	3	2	poor	Multistem 2, mostly dead crown, trunk rot and straps	Direct conflict with proposed construction	remove	none

95	<i>Agilops nigra</i> Black Walnut	City ROW Colonel Talbot	20	2	5	fair	good primary union	Direct conflict with proposed construction	remove	none
96	<i>Agilops nigra</i> Black Walnut	City ROW Colonel Talbot	18	2	5	fair	good primary union	Direct conflict with proposed construction	remove	none
97	<i>Agilops nigra</i> Black Walnut	Subject site	10	2	5	good	good	Direct conflict with proposed construction	remove	none
98	<i>Populus deltoides</i> Cottonwood	Subject site	10	2.5	5	fair	Good beside old concrete blocks	Direct conflict with proposed construction	remove	none
99	<i>Populus deltoides</i> Cottonwood	Subject site	12	2.5	5	fair	Good beside old concrete blocks	Direct conflict with proposed construction	remove	none
100	<i>Agilops nigra</i> Black Walnut	Subject site	12	1.5	5	good	good	Direct conflict with proposed construction	remove	none
101	<i>Prunus sp.</i> Cherry	Subject site	15, 11	2	4	poor	columnar leaders, one trunk ragged at base, trunk cavity forming	Direct conflict
