TREE ASSESSMENT REPORT FOR REZONING APPLICATION

50 KING ST. & 399 RIDOUT ST.
LONDON, ONTARIO

Report prepared by
Ron Koudys Landscape Architects Inc

RKLA Project #21-293

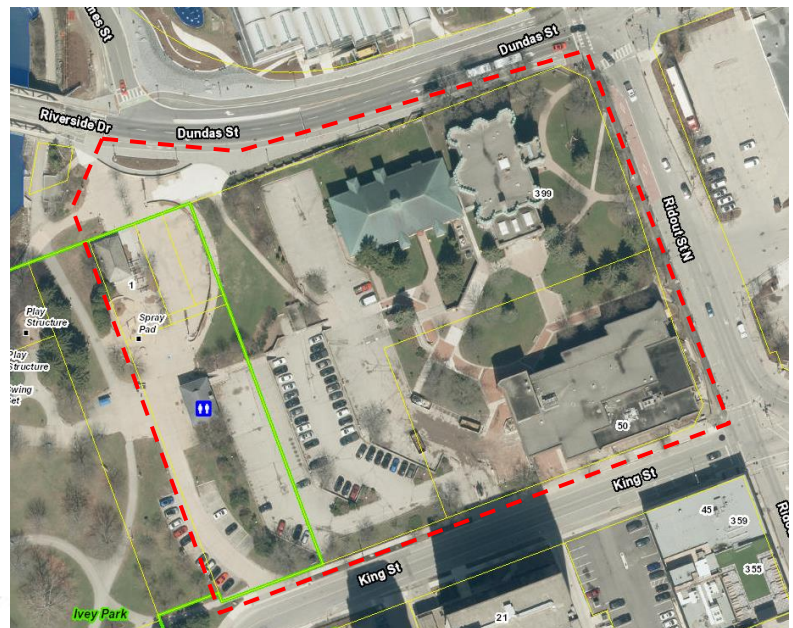
Figure 1 - City of London mapping with 2022 aerial imagery. NTS

Red dashed line - Limit of inventory

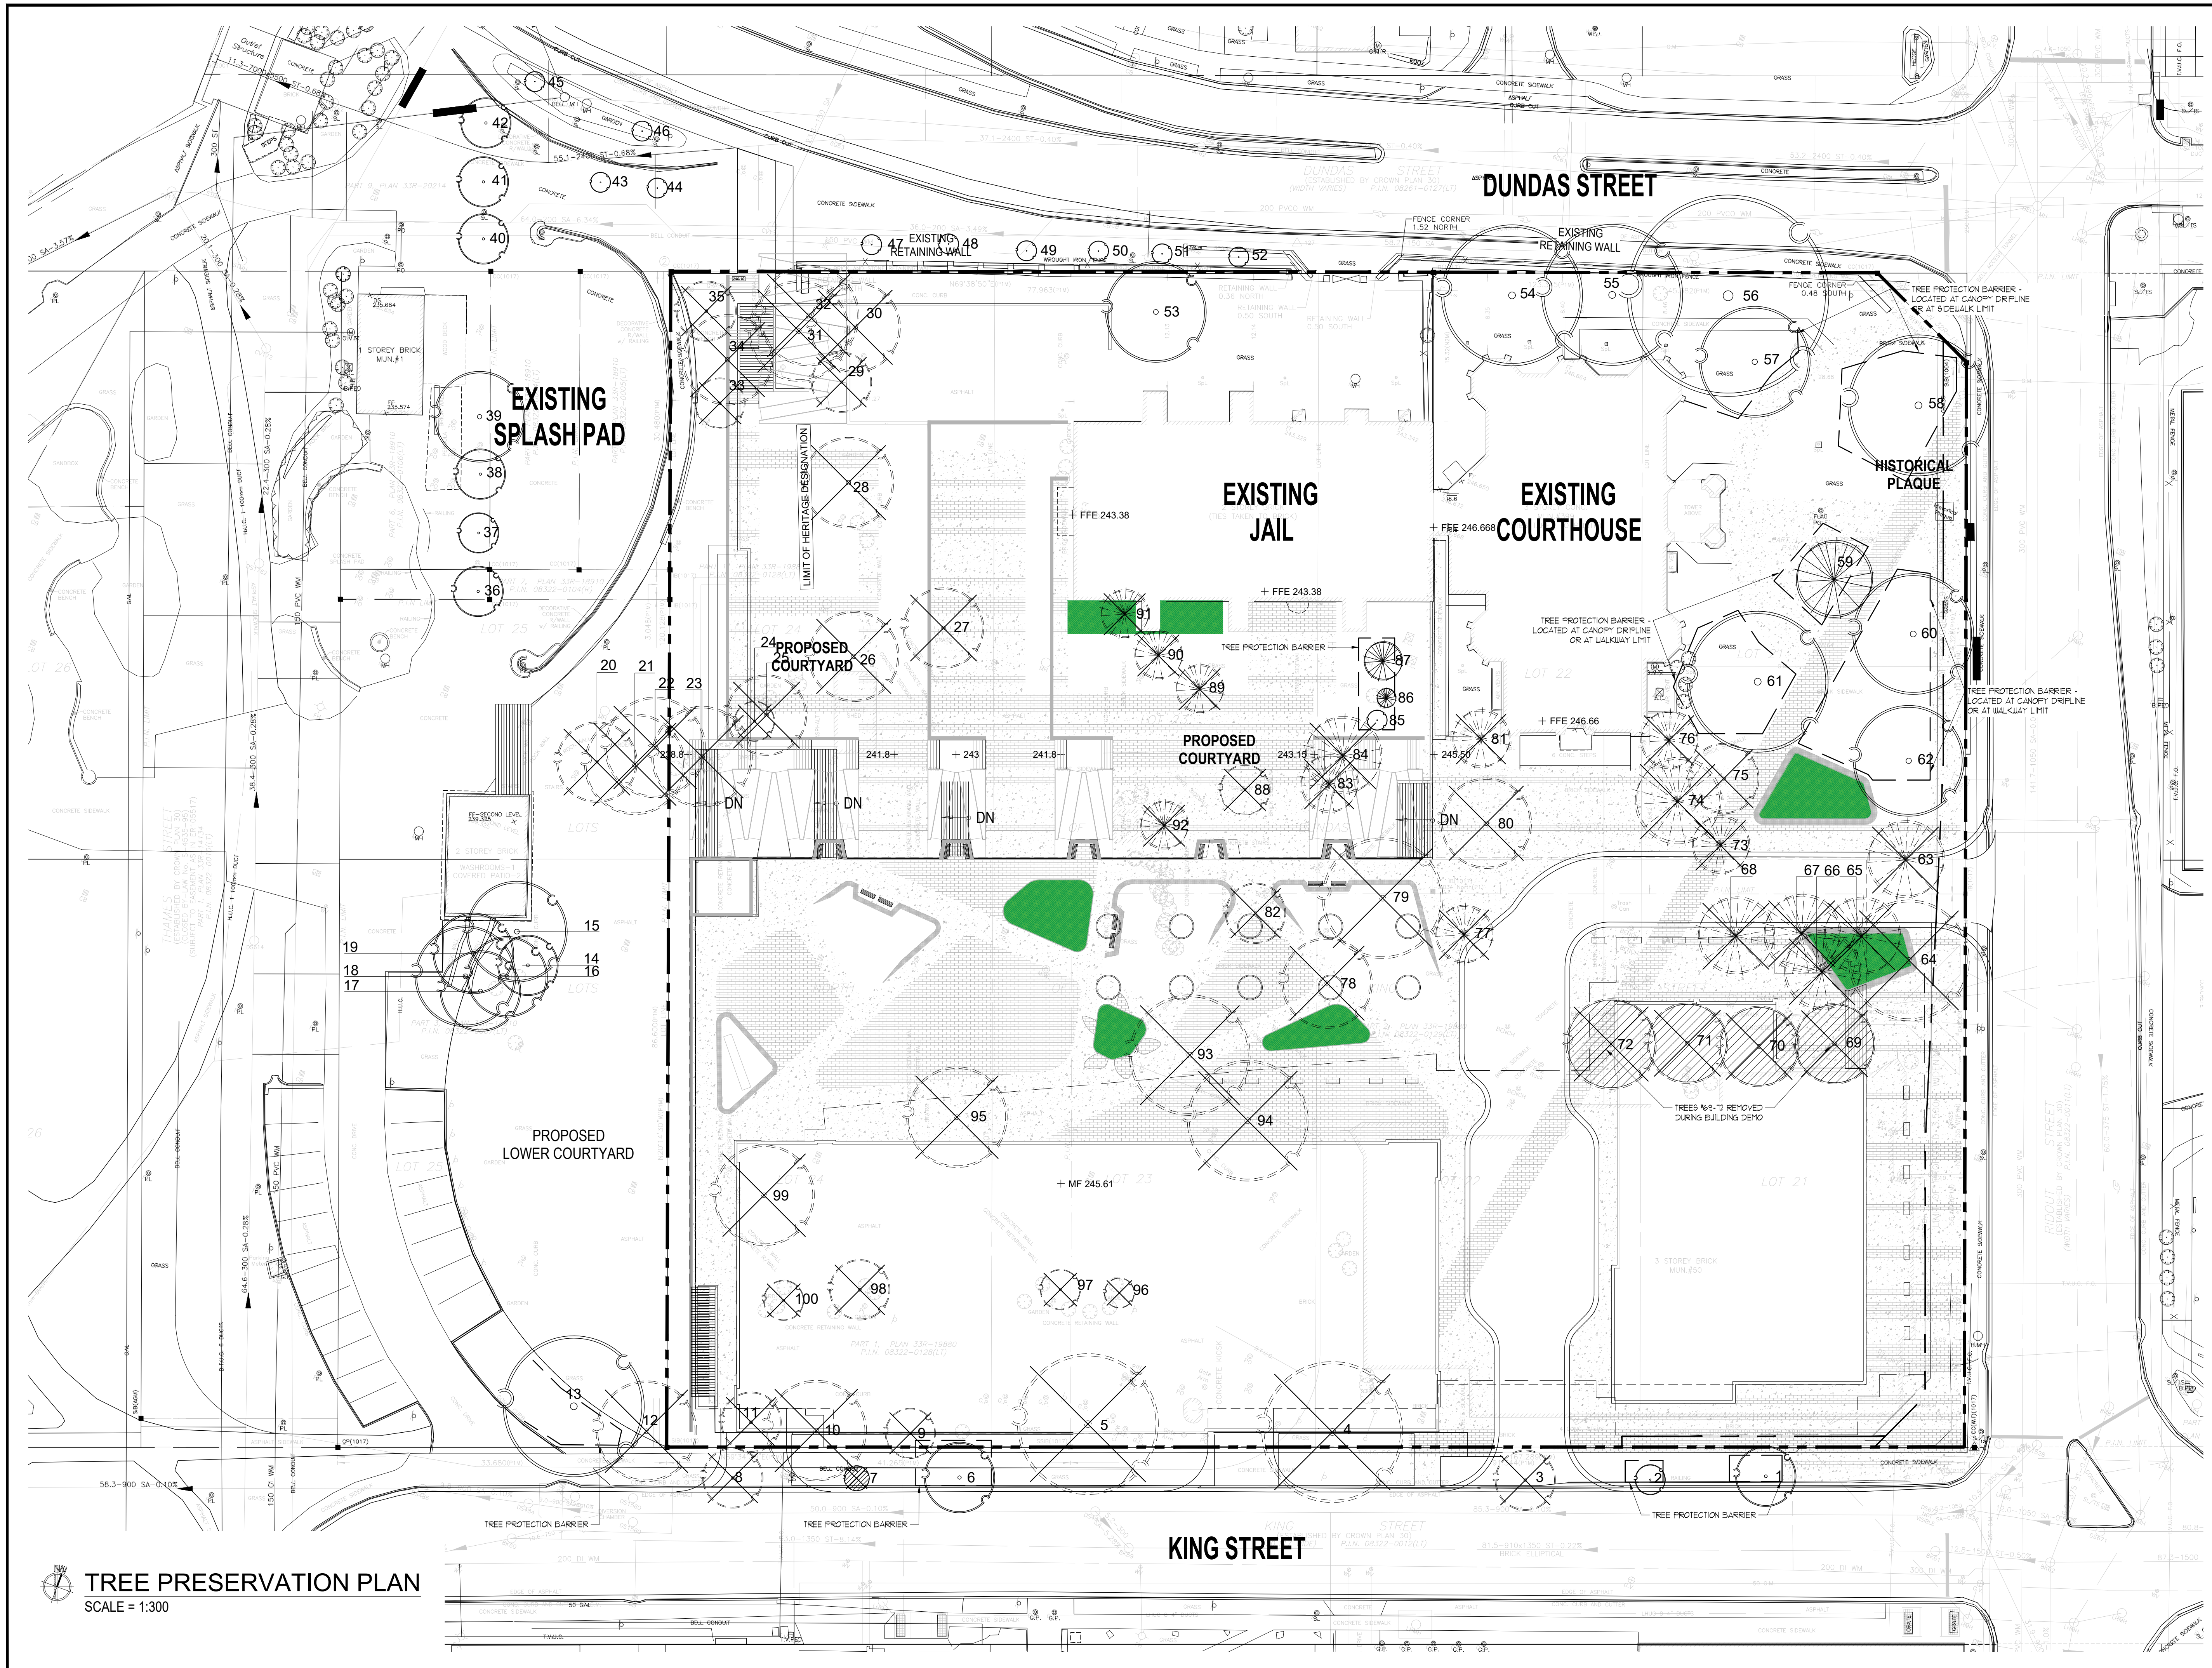
DRAWING TITLE:
TREE PRESERVATION PLAN

TREE PRESERVATION PLAN
 SCALE = 1:300

- a) Prior to any construction activity, tree preservation fencing is to be installed as per the attached tree preservation drawings and detail.
- b) Trees approved for removal are to be clearly indicated in the field (marked with spray paint or other agreed upon method) by the project arborist or landscape architect prior to any tree removal operations. All removals to be undertaken by an ISA certified arborist.

- a) Tree preservation fencing is to be maintained in good condition and effective for the duration of construction until all construction activity is complete or as per the project arborist or landscape architect.

- b) Tree preservation fencing is to remain intact as per the tree preservation drawings, and can only be temporarily removed with the express written consent from the project arborist or landscape architect. Should tree preservation fencing be temporarily relocated or moved, it is to be reinstated as per the tree preservation plans as soon as possible.

- c) No construction, excavation, adding of fill, stockpiling of construction material, or heavy equipment is permitted within the critical root zone/within the tree preservation fencing.
