634 COMMISSIONERS ROAD WEST  
LONDON, ONTARIO  
TREE ASSESSMENT REPORT  
FOR ZBA

PREPARED BY: RON KOUDYS LANDSCAPE  
ARCHITECTS INC

DATE: NOVEMBER, 2023

RKLA PROJECT #: 22-182

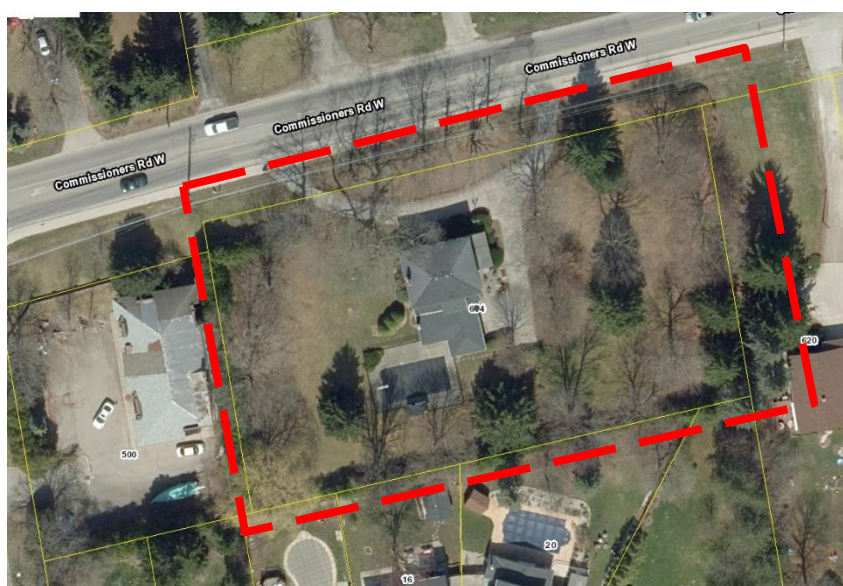
Figure 1 - Image capture from City of London mapping  
Red dashed line - limit of tree inventory
