TREE PRESERVATION REPORT FOR ZONING BY-LAW AMENDMENT

**1170 FANSHAWE PARK ROAD
LONDON, ONTARIO**

Report prepared by
Ron Koudys Landscape Architects Inc

RKLA Project #22-196

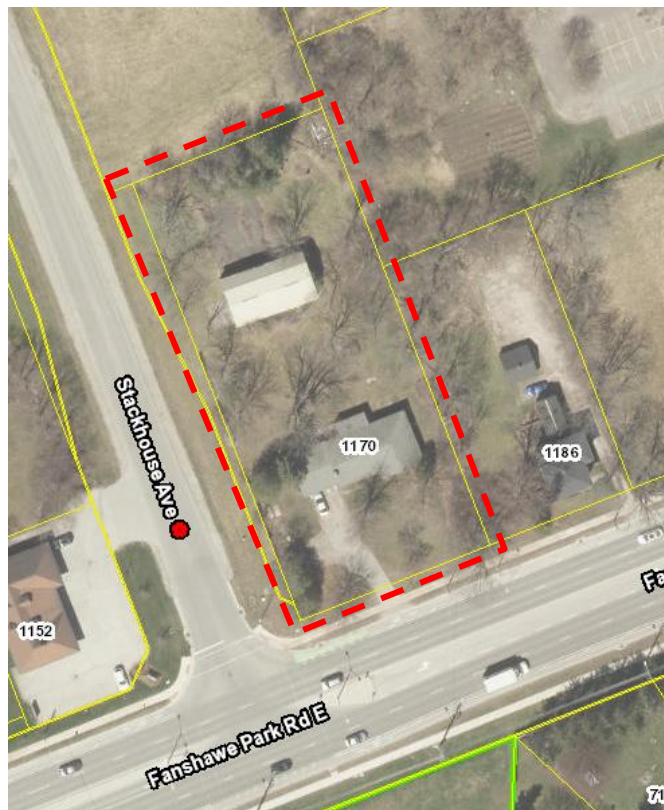
Figure 1 - City of London mapping with 2023 aerial imagery. NTS

Red dashed line - Limit of inventory

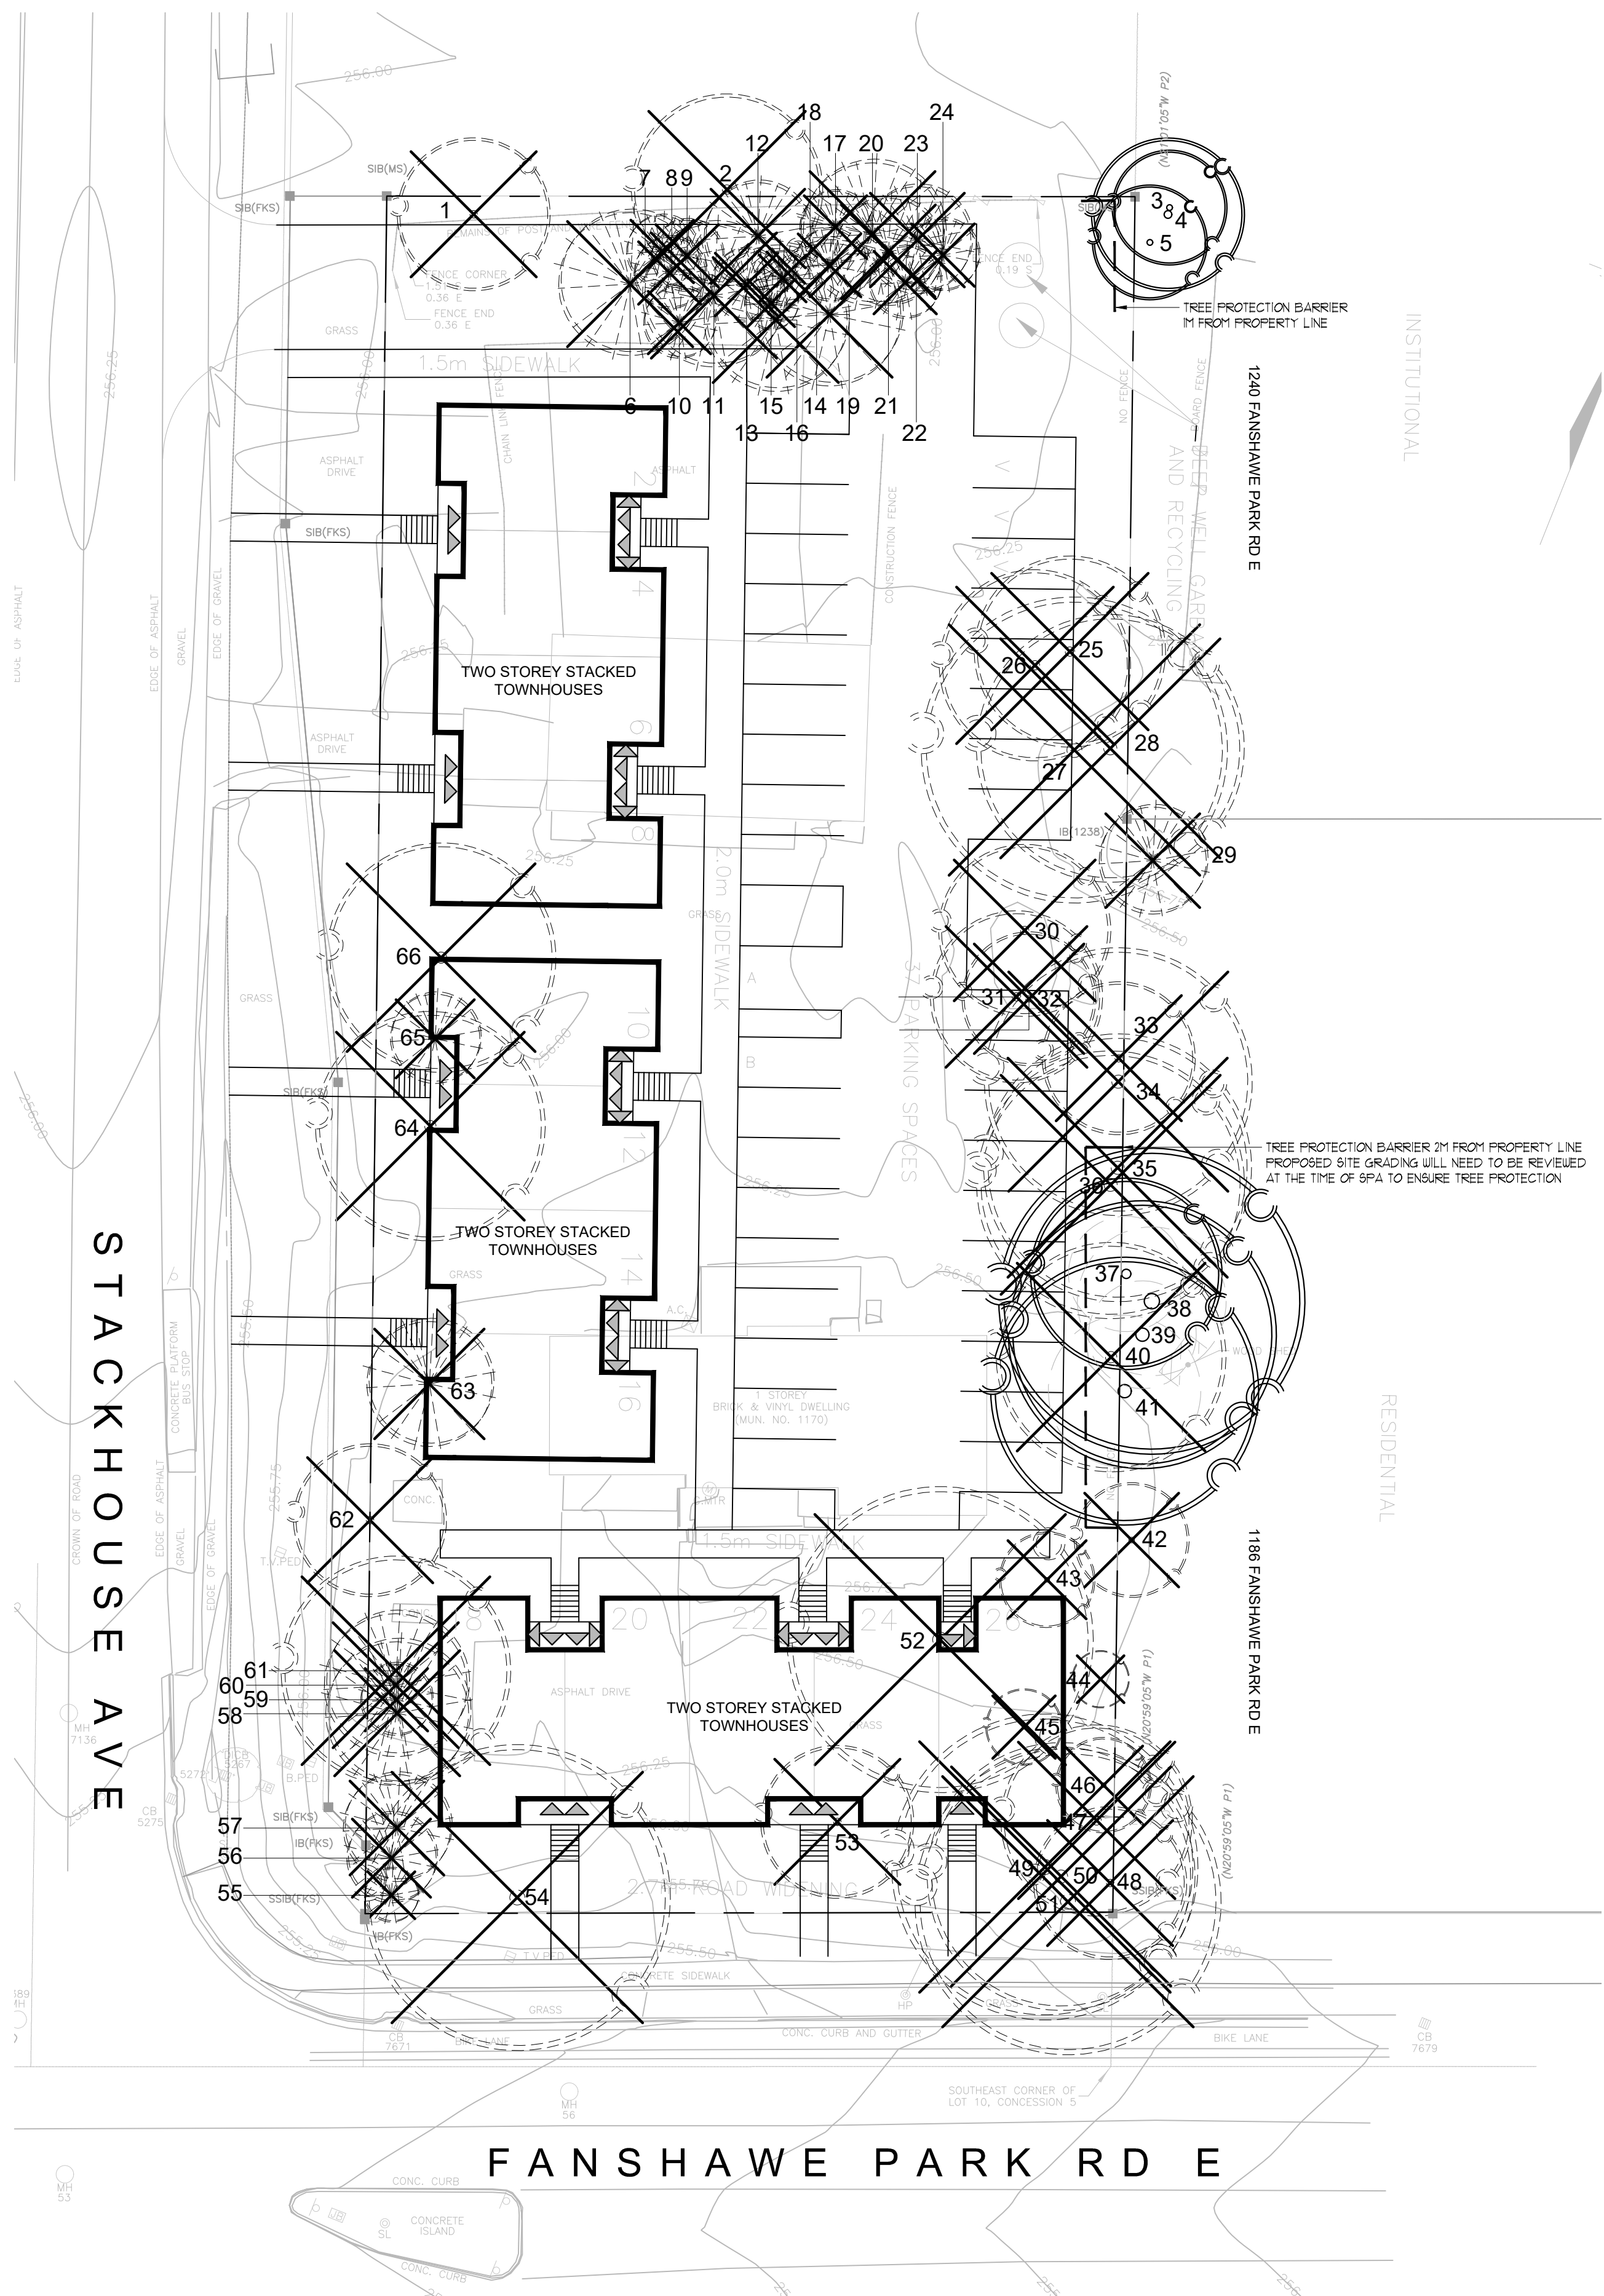
DRAWING TITLE:
TREE PRESERVATION PLAN

The following recommendations are based on requirements of the current site plan. Grey indicates recommended removal.

- a) Prior to any construction activity, tree preservation fencing is to be installed as per the attached tree preservation drawings and detail.
- b) Trees approved for removal are to be clearly indicated in the field (marked with spray paint or other agreed upon method) by the project arborist or landscape architect prior to any tree removal operations. All removals to be undertaken by an ISA certified arborist.

- c) No construction, excavation, adding of fill, stockpiling of construction material, or heavy equipment is permitted within the critical root zone/within the tree preservation fencing.
