TREE PRESERVATION REPORT FOR ZONING BY-LAW AMENDMENT

**300-306 PRINCESS AVE
LONDON, ONTARIO**

Report prepared by
Ron Koudys Landscape Architects Inc

RKLA Project #23-228

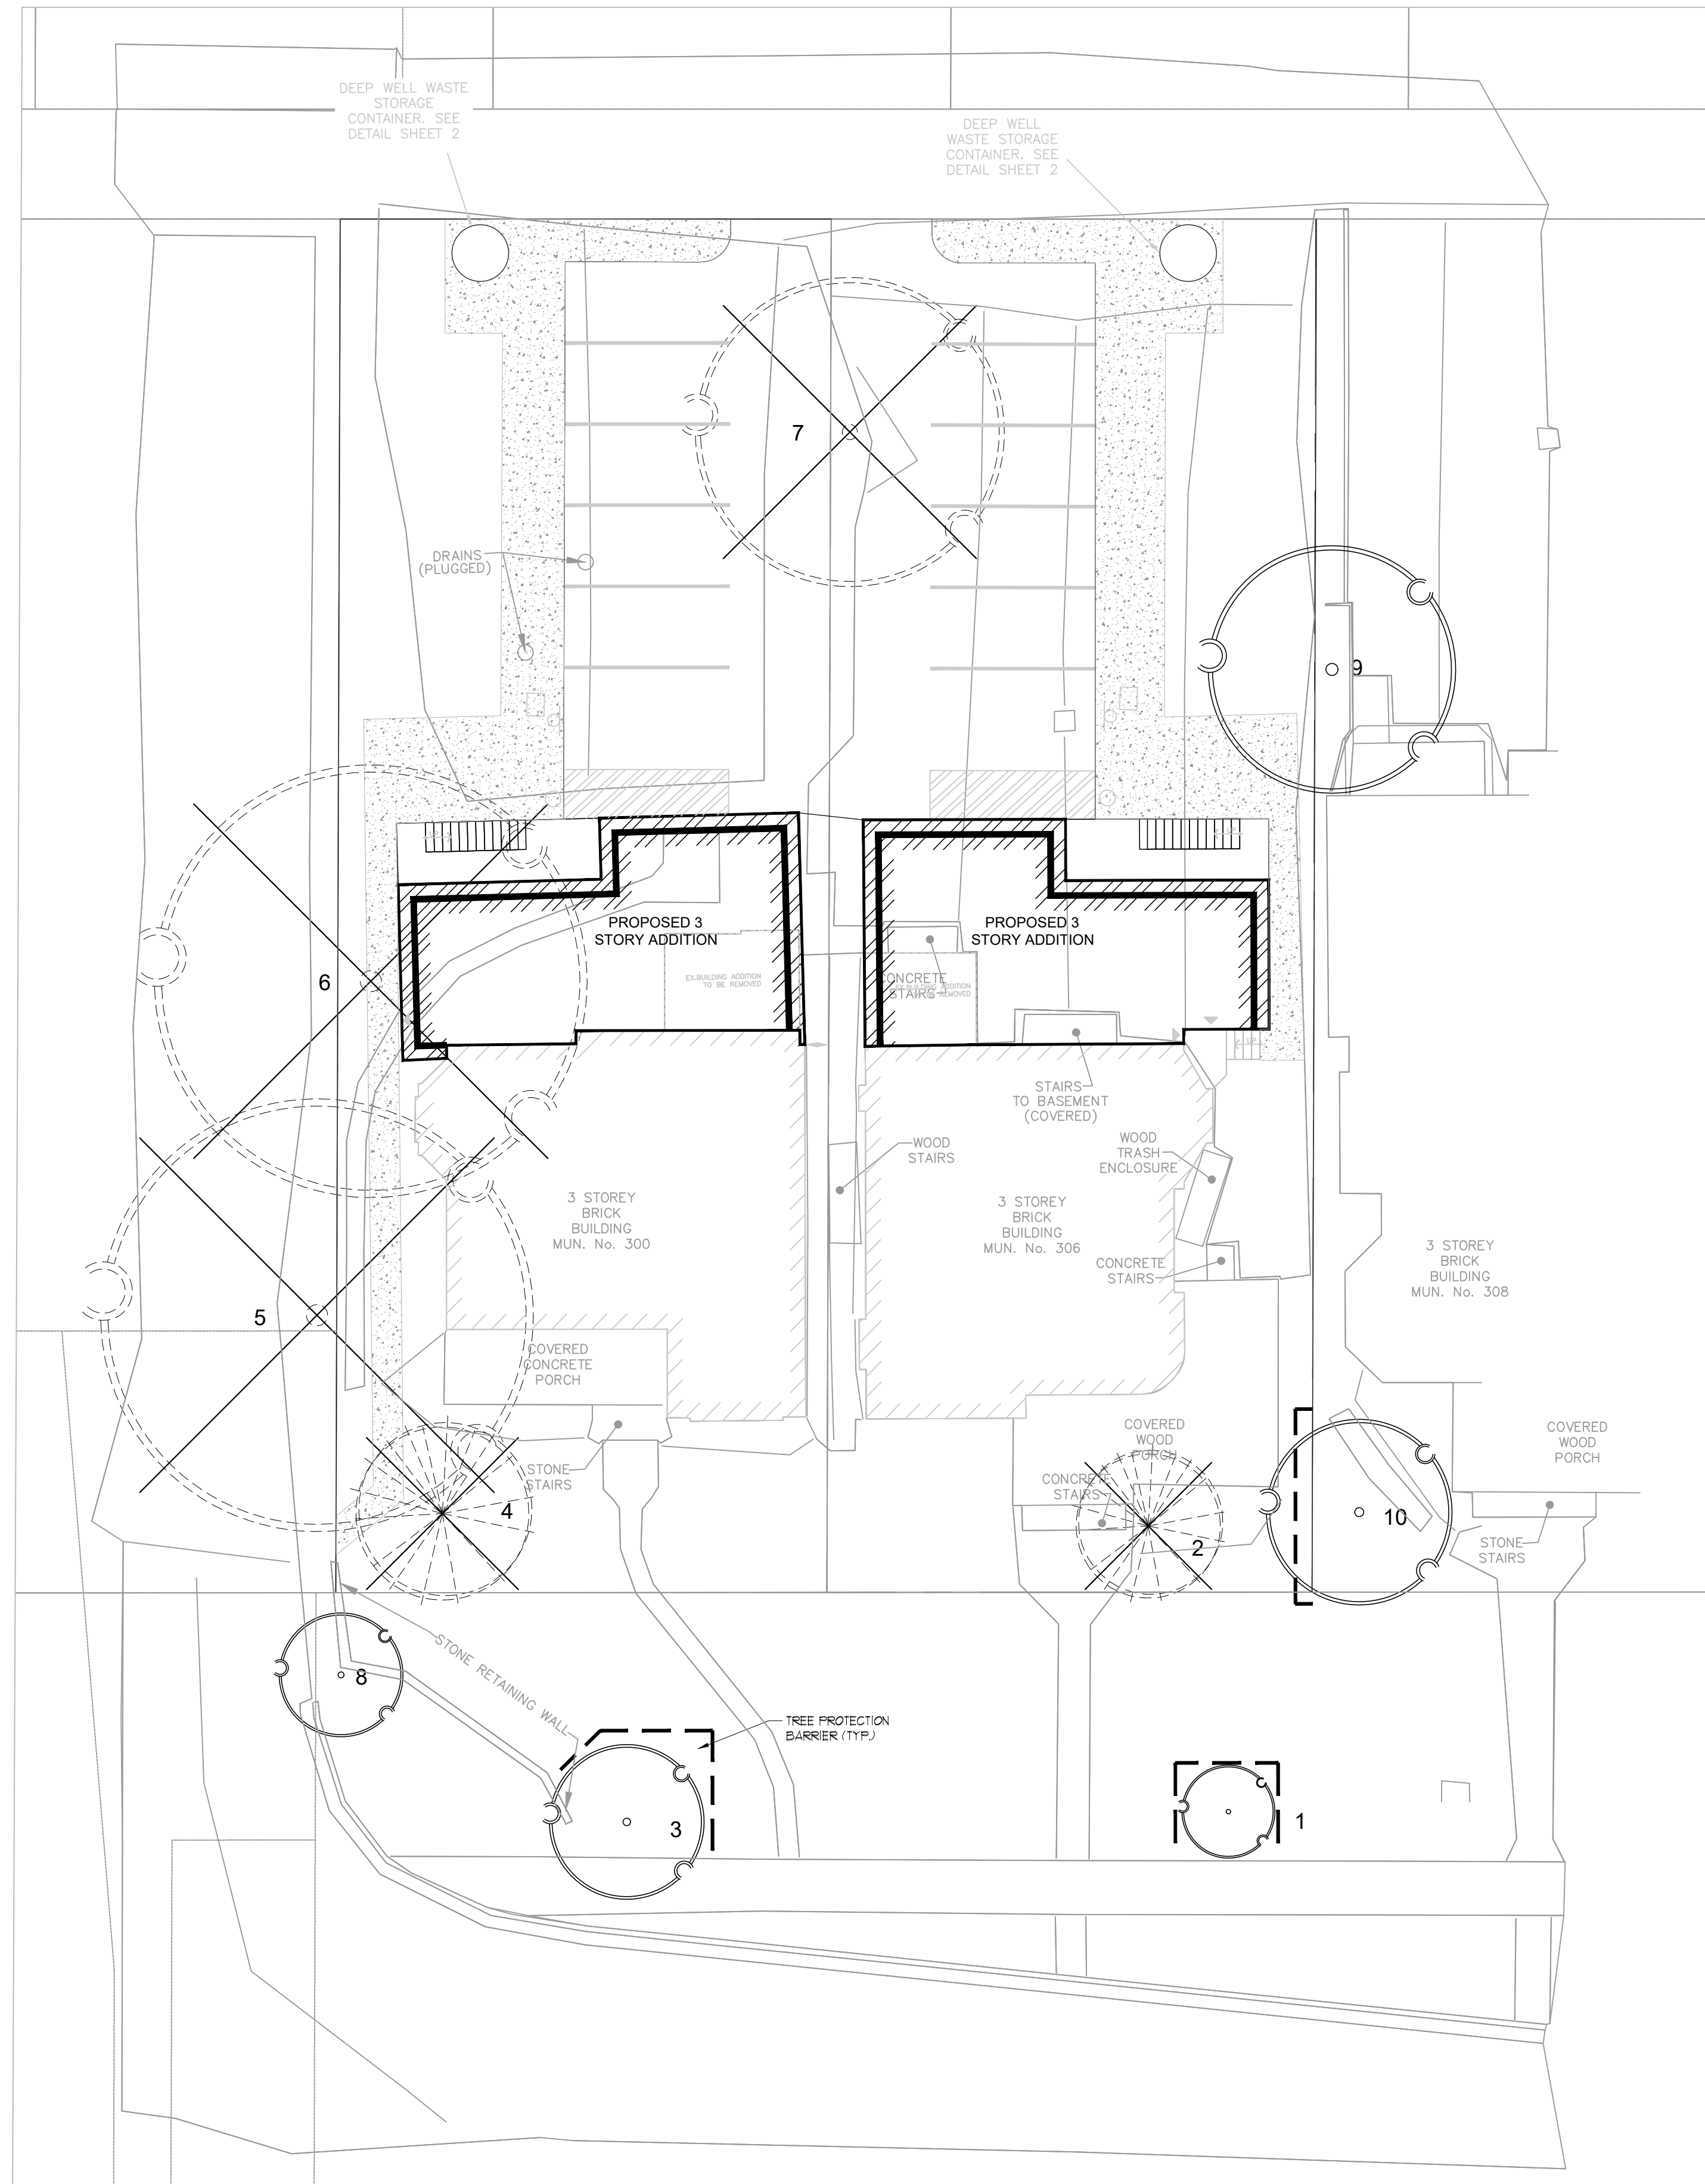
TREE PRESERVATION PLAN
SCALE = 1:150

ID #	GENERAL INFORMATION			SIZE				HEALTH & CONDITION		RECOMMENDATIONS		
	BOTANICAL NAME	COMMON NAME	LOCATION	DBH (cm)	CANOPY RADIIUS (m)	CROWN CONDITION	STRUCTURAL FORM	STRUCTURAL INTEGRITY	COMMENTS	EXPECTED CONSTRUCTION IMPACTS	PRESERVE OR REMOVE	IMPACT MITIGATION or REMOVAL RATIONALE
2	<i>Picea pungens</i>	Colorado Spruce	306 Princess Ave (subject site)	27	25	4	fair	fair	Slight lean to west onto existing porch	no expected impacts	remove	poor tree condition
4	<i>Picea pungens</i>	Blue Spruce	300 Princess Ave (subject site)	40	3		poor	fair	Bark slough	no expected impacts	remove	poor tree condition
5	<i>Celtis occidentalis</i>	Hackberry	291 Wolfe Street	69	7	5	poor	poor	Dominate leaders with included bark	conflict with proposed walkway	remove	poor tree condition and construction conflict <i>distinctive tree permit required</i>
6	<i>Morus alba</i>	White Mulberry	300 Princess Ave (subject site)	81, 29	7	5	poor	fair	Leaning west on fence line	conflict with proposed walkway and proposed	remove	poor tree condition and construction conflict <i>distinctive tree permit</i>

7	<i>Ulmus americana</i>	White Elm	306 Princess Ave (subject site)	55	5	5	fair	good		conflict with proposed parking lot	remove	construction conflict <i>distinctive tree permit</i>

ID #	GENERAL INFORMATION			SIZE			HEALTH & CONDITION		RECOMMENDATIONS			
	BOTANICAL NAME	COMMON NAME	LOCATION	DBH (cm)	CANOPY RADIIUS (m)	CROWN CONDITION	STRUCTURAL FORM	STRUCTURAL INTEGRITY	COMMENTS	EXPECTED CONSTRUCTION IMPACTS	PRESERVE OR REMOVE	IMPACT MITIGATION or REMOVAL RATIONALE
1	<i>Quercus rubra</i>	Red Oak	City ROW Princess Ave	6	15	5	good	good	Slight lean west	no expected impacts	preserve	tree protection barrier
3	<i>Platanus x acerifolia</i>	London Plane Tree	City ROW Princess Ave	14	25	5	good	good	Minor basal wound	no expected impacts	preserve	tree protection barrier
8	<i>Ailanthus altissima</i>	Tree of Heaven	City ROW Princess Ave	18, 10	2	4	fair	fair	Primary union at grade	no expected impacts	preserve	N/A
9	<i>Acer platanoides</i>	Norway Maple	308 Princess Ave (subject site)	40	4	3	poor	fair	Bark slough, large weeping wound	no expected impacts	preserve	N/A
10	<i>Acer saccharinum</i>	Gulfed Silver Maple	308 Princess Ave (subject site)	59	3	3	poor	fair	Weeping wounds, cavities forming	no expected impacts	preserve	tree protection barrier
