TREE PRESERVATION REPORT FOR ZONING BY-LAW AMENDMENT

**WHITE OAKS APARTMENTS SITE 1
1105 WELLINGTON ROAD,
LONDON, ONTARIO**

Report prepared by
Ron Koudys Landscape Architects Inc

RKLA Project #24-109

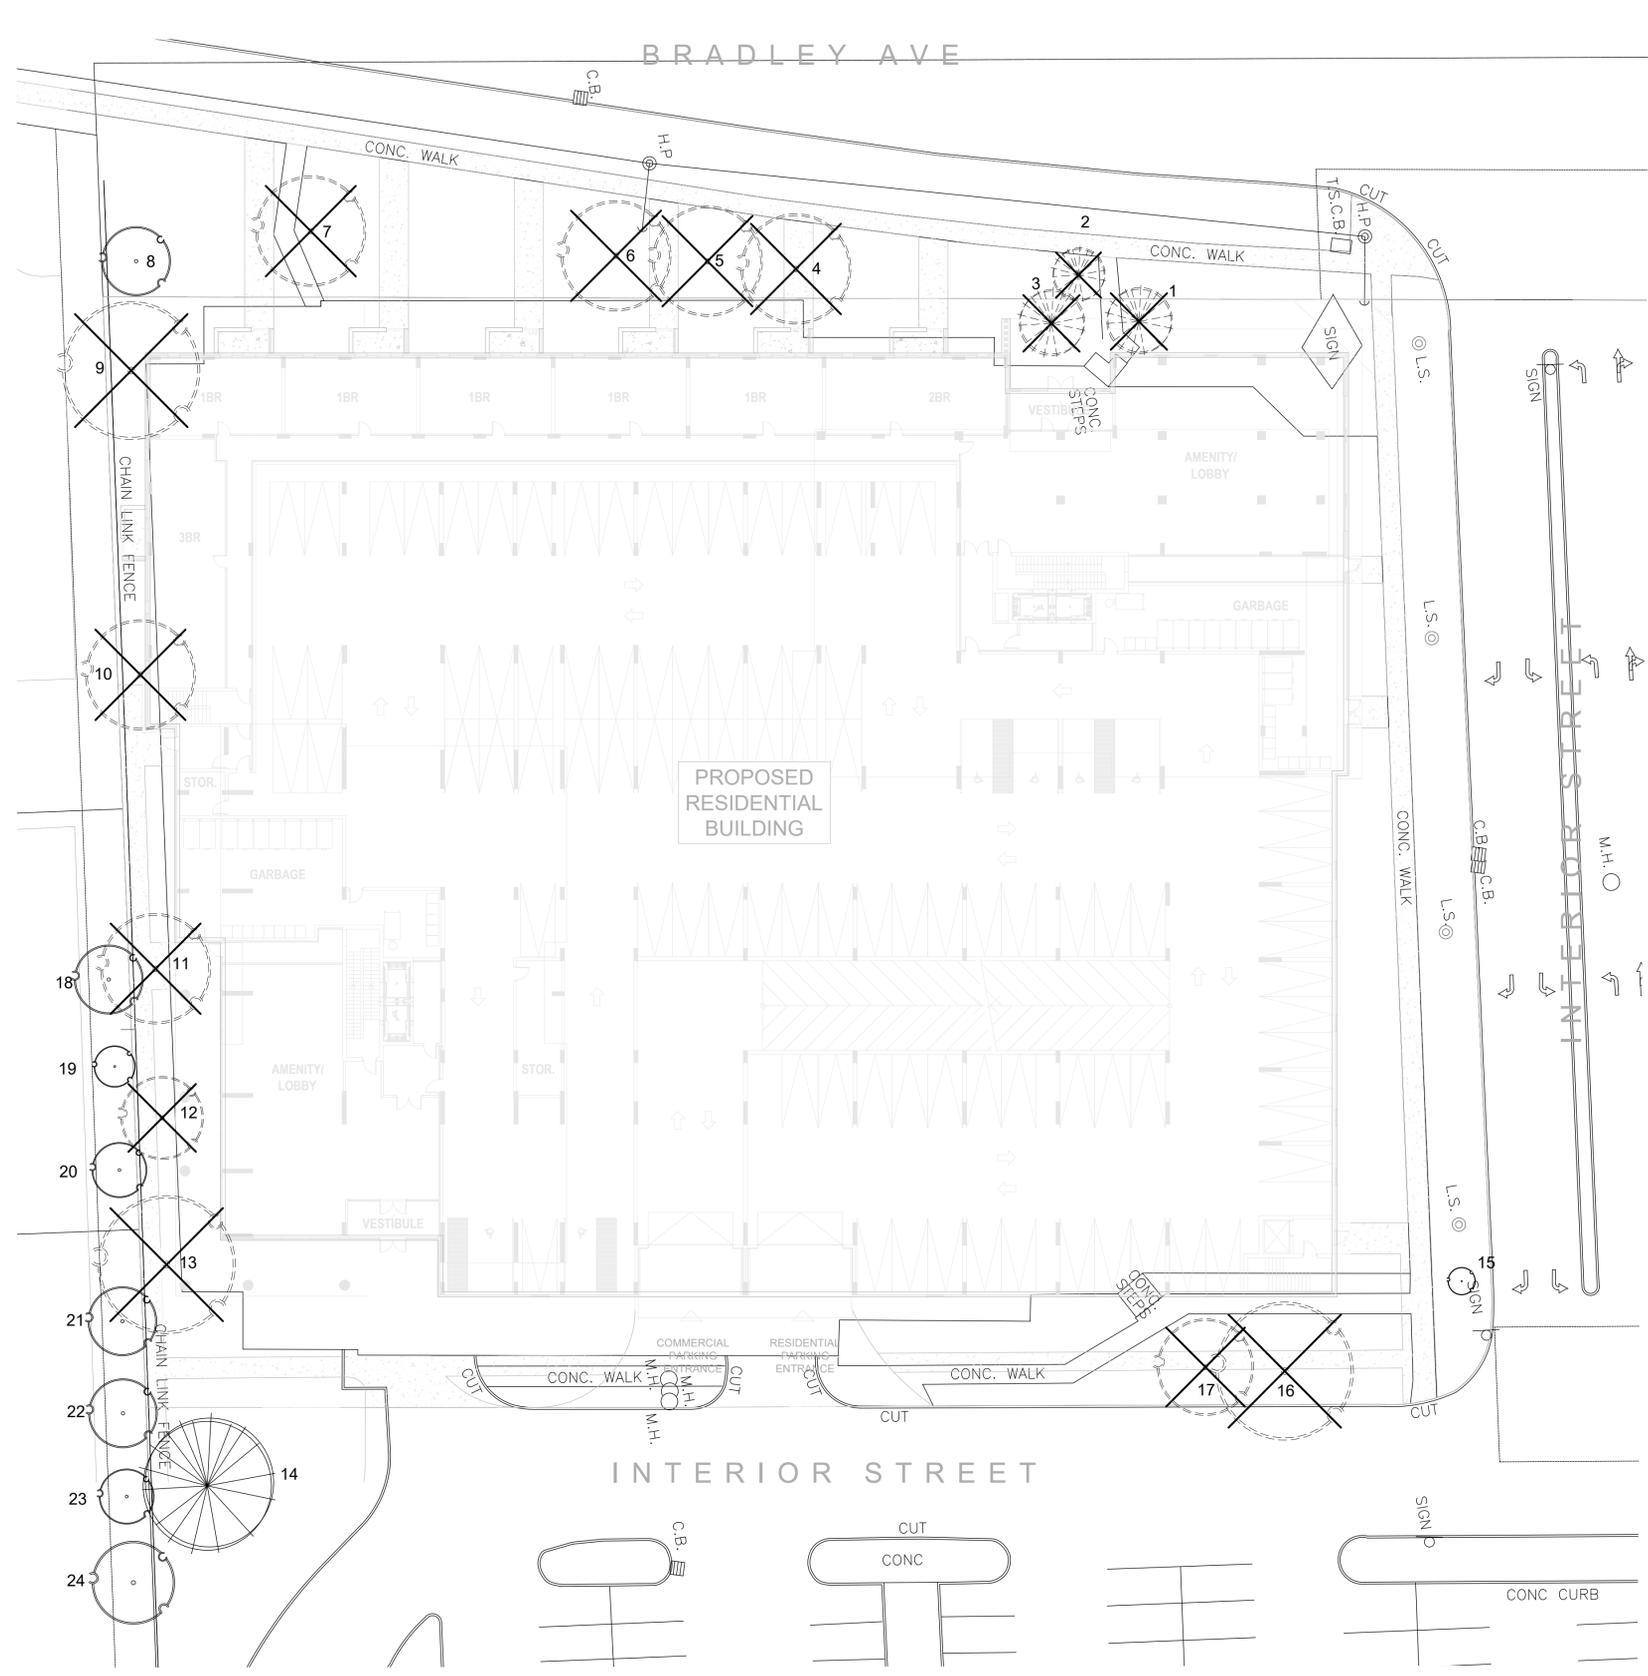
TREE PRESERVATION PLAN
 SCALE = 1:250

ID #	BOTANICAL NAME	COMMON NAME	LOCATION	SIZE (DBH (cm))	HEALTH & CONDITION	COMMENTS	EXPECTED CONSTRUCTION IMPACT	RECOMMENDATIONS	NOTES	
1	<i>Picea purpura</i>	Colorado Spruce	Subject Site	28	2.5	3 Fair	significant lean east	conflict with proposed construction and tree condition	remove	
2	<i>Picea purpura</i>	Colorado Spruce	City ROW Bradley Ave	21	2	3 Fair	lean south, exposed roots, topped	conflict with proposed construction and tree condition	remove	consent from the City of London required
3	<i>Picea purpura</i>	Colorado Spruce	Subject Site	40	2.5	2 Fair	exposed roots	conflict with proposed construction and tree condition	remove	
4	<i>Acer saccharinum</i>	Silver Maple	City ROW Bradley Ave	37	4	5 Fair	cavity forming at primary union	conflict with proposed construction and tree condition	remove	consent from the City of London required
5	<i>Acer saccharinum</i>	Silver Maple	City ROW Bradley Ave	38	4	4 Fair	included bark at attachment, epicormic growth, minor dead wood in canopy	conflict with proposed construction and tree condition	remove	consent from the City of London required

6	<i>Acer saccharinum</i>	Silver Maple	City ROW Bradley Ave	45	4	4 Fair	epicormic growth, cavities forming at primary union	conflict with proposed construction and tree condition	remove	consent from the City of London required
7	<i>Acer platanoides</i>	Norway Maple	City ROW Bradley Ave	38	4	5 Fair	minor split in trunk with cavity forming	conflict with proposed construction and tree condition	remove	consent from the City of London required
8	<i>Acer platanoides</i>	Norway Maple	Subject Site	47	5	5 Good	slight lean	conflict with proposed construction	remove	
9	<i>Acer platanoides</i>	Norway Maple	Subject Site	36	4	5 Fair	lean north, cavities forming	conflict with proposed construction	remove	
10	<i>Acer platanoides</i>	Norway Maple	Subject Site	32	4	3 Fair	major cavities	conflict with proposed construction	remove	
11	<i>Acer platanoides</i>	Norway Maple	Subject Site	29	3	4 Fair	dead wood in crown	conflict with proposed construction	remove

12	<i>Acer platanoides</i>	Norway Maple	Subject Site	39	5	5 Fair	exposed roots	conflict with proposed construction	remove	
13	<i>Acer platanoides</i>	Norway Maple	Subject Site	35	5	3 Poor	dead wood, exposed circling roots	conflict with proposed construction and tree condition	remove	
14	<i>Acer platanoides</i>	Norway Maple	Subject Site	29	3.5	2 Fair	cavity at primary union, deadwood, exposed roots	conflict with proposed construction and tree condition	remove

ID #	BOTANICAL NAME	COMMON NAME	LOCATION	SIZE (DBH (cm))	HEALTH & CONDITION	COMMENTS	EXPECTED CONSTRUCTION IMPACT	RECOMMENDATIONS	NOTES	
15	<i>Lilac cordata</i>	Little Leaf Linden	City ROW Bradley Ave	28	2.5	5 Fair	burts in trunk	potential conflict with site grading	preserve	tree protection barrier
16	<i>Pinus strobus</i>	Austrian Pine	Subject Site	47.42	4	5 Fair	codominant, primary union at grade	potential conflict with site grading	preserve	tree protection barrier
17	<i>Gelitis occidentalis</i>	Haskberry	Subject Site	5	1	5 Good	recently planted, staked	potential conflict with site grading	preserve	tree protection barrier
18	<i>Acer saccharum</i>	Sugar Maple	100 Jaina Boulevard	24	2.5	5 Fair	Canopy heavy west	potential conflict with site grading	preserve	tree protection barrier
19	<i>Acer saccharum</i>	Sugar Maple	100 Jaina Boulevard	16	1.5	4 Poor	Basal wound, major cracks in trunk, large branches removed at primary union	potential conflict with site grading	preserve	tree protection barrier

20	<i>Acer saccharum</i>	Sugar Maple	100 Jaina Boulevard	17	2	4 Fair	Basal wound, major wounds on trunk	potential conflict with site grading	preserve	tree protection barrier
21	<i>Acer saccharum</i>	Sugar Maple	100 Jaina Boulevard	25	2.5	4 Fair	Slight lean in trunk, basal wound, old grape wounds, multiple broken branches in canopy	potential conflict with site grading	preserve	tree protection barrier
22	<i>Acer saccharum</i>	Sugar Maple	100 Jaina Boulevard	23	2.5	5 Fair	Good	potential conflict with site grading	preserve	tree protection barrier
23	<i>Acer saccharum</i>	Sugar Maple	100 Jaina Boulevard	18	2	5 Fair	Multiple broken branches in canopy	potential conflict with site grading	preserve	tree protection barrier
24	<i>Acer saccharum</i>	Sugar Maple	100 Jaina Boulevard	26	3	5 Fair	Minor basal wound	potential conflict with site grading	preserve	tree protection barrier
