TREE ASSESSMENT REPORT

ADELAIDE STREET NORTH MUNICIPAL CLASS ENVIRONMENTAL
ASSESSMENT

FROM FANSHAWE PARK ROAD EAST TO SUNNINGDALE ROAD EAST
LONDON, ONTARIO

RKLA Project # 18-191

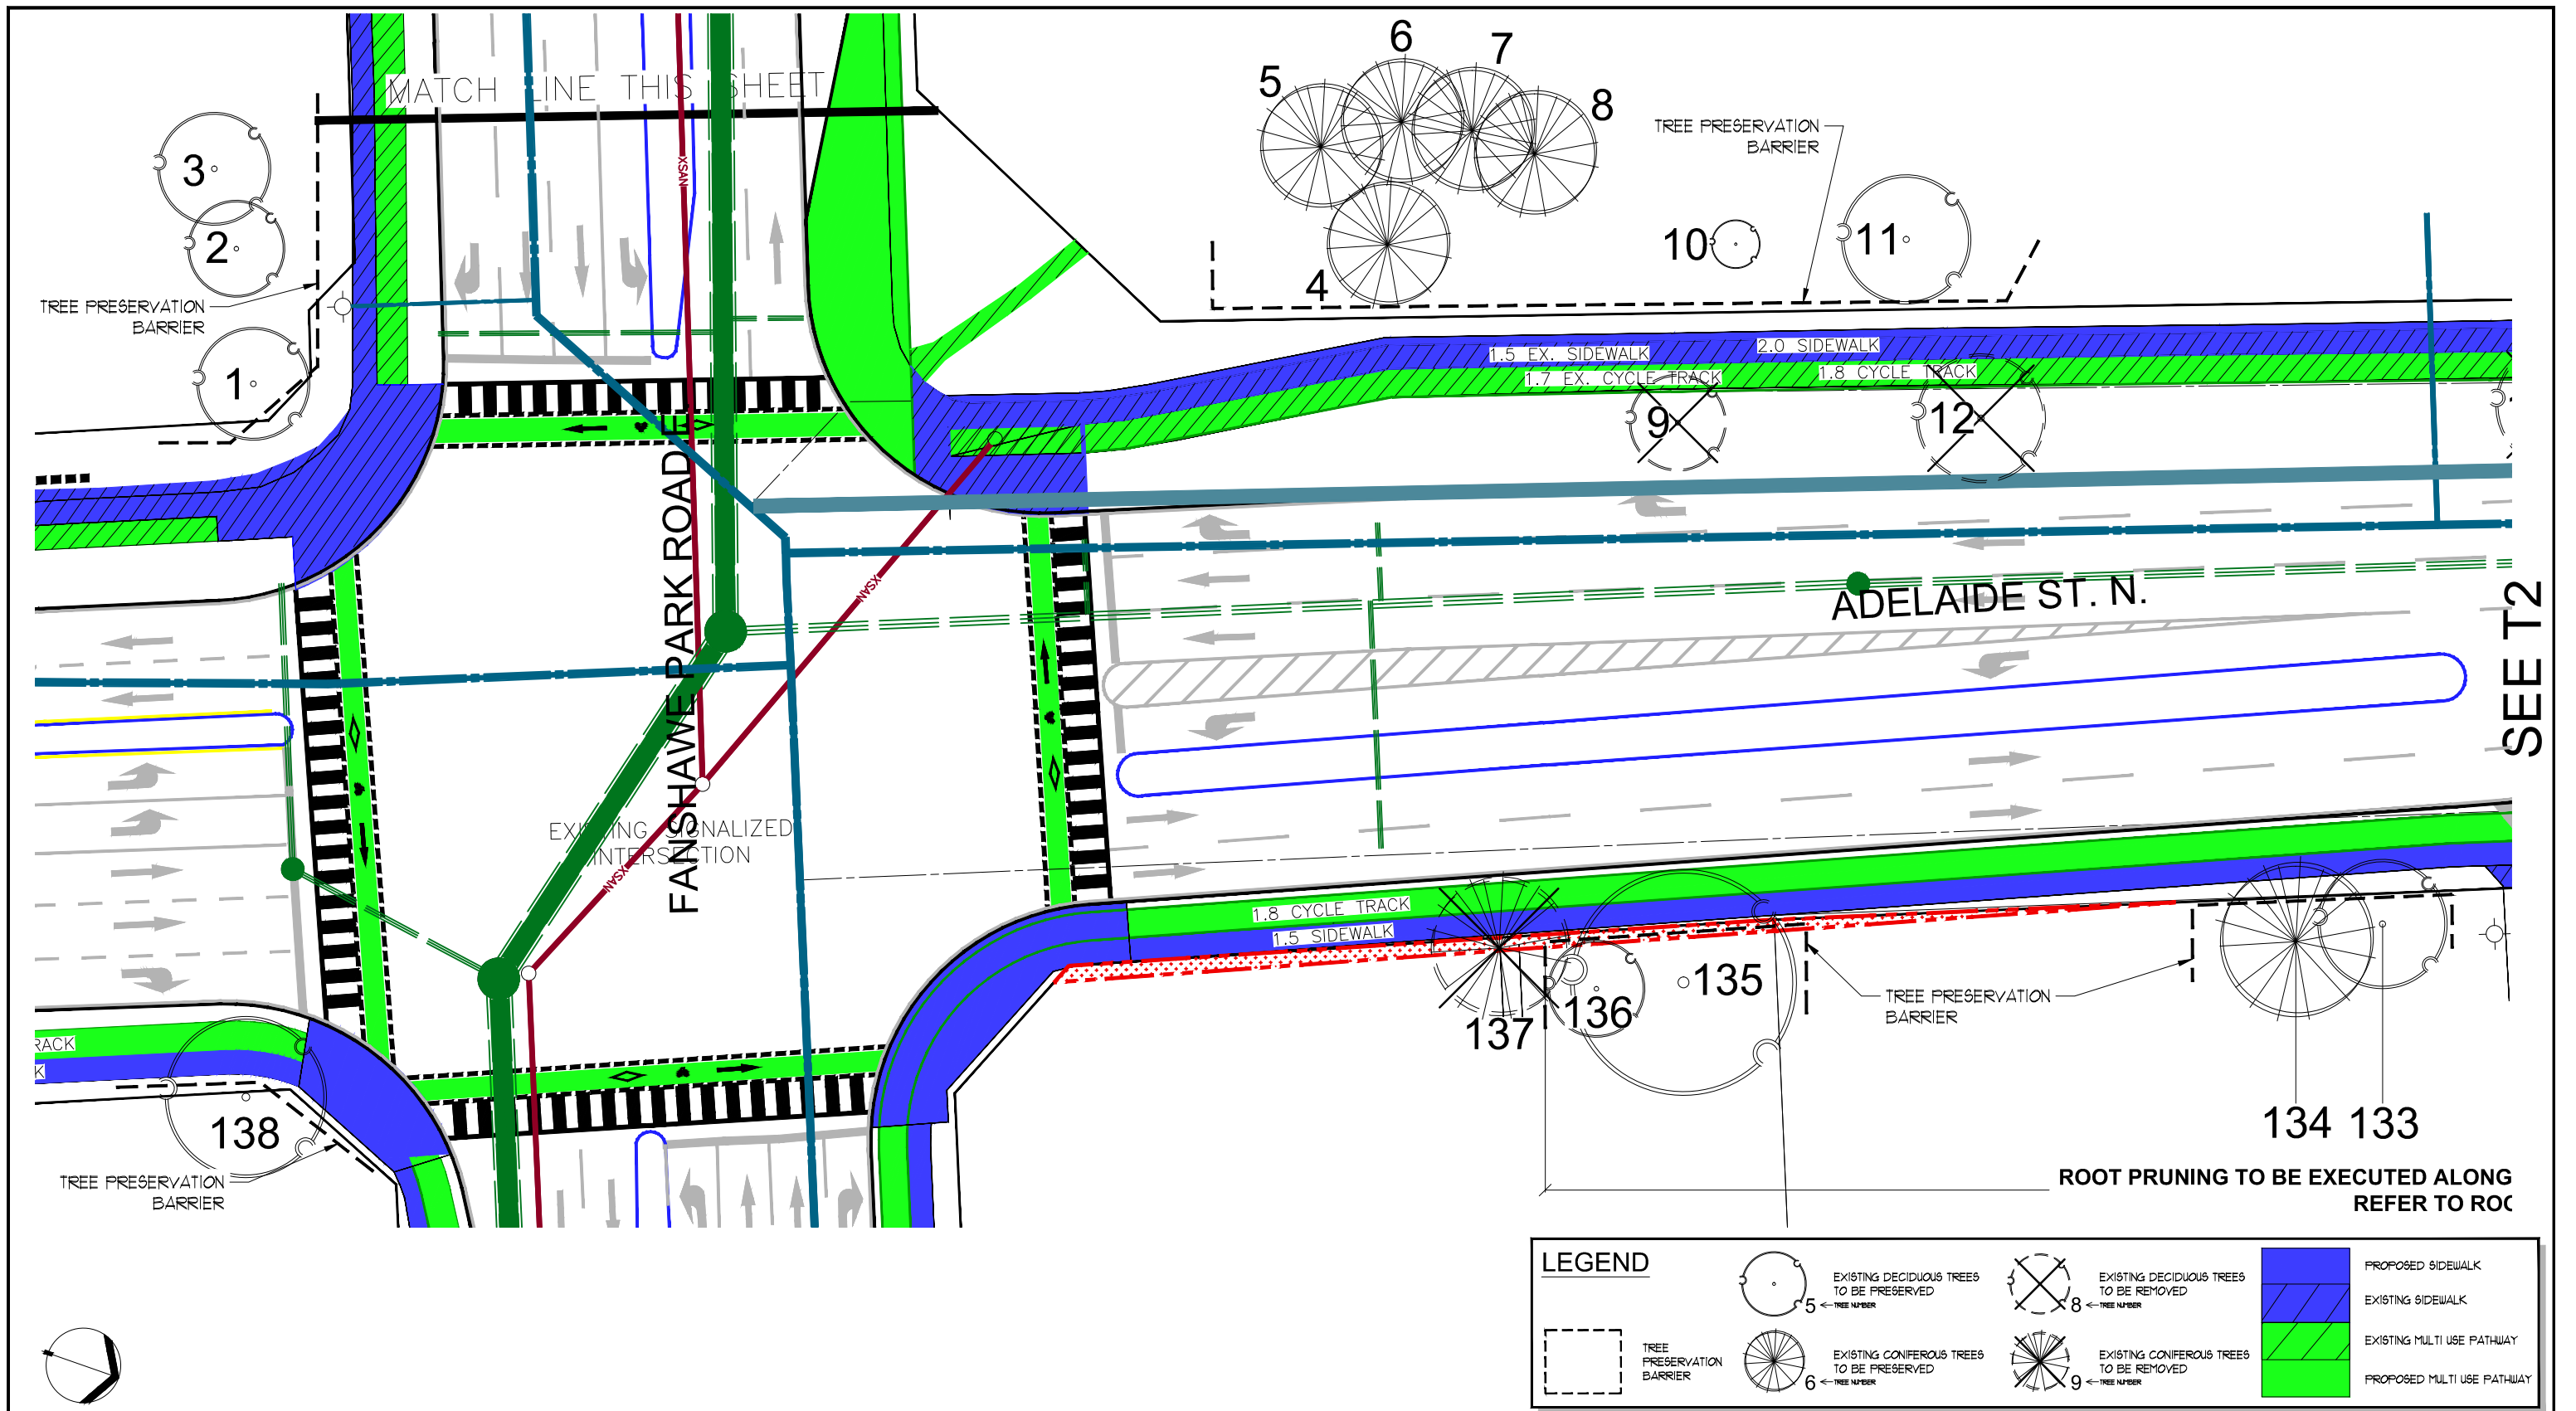
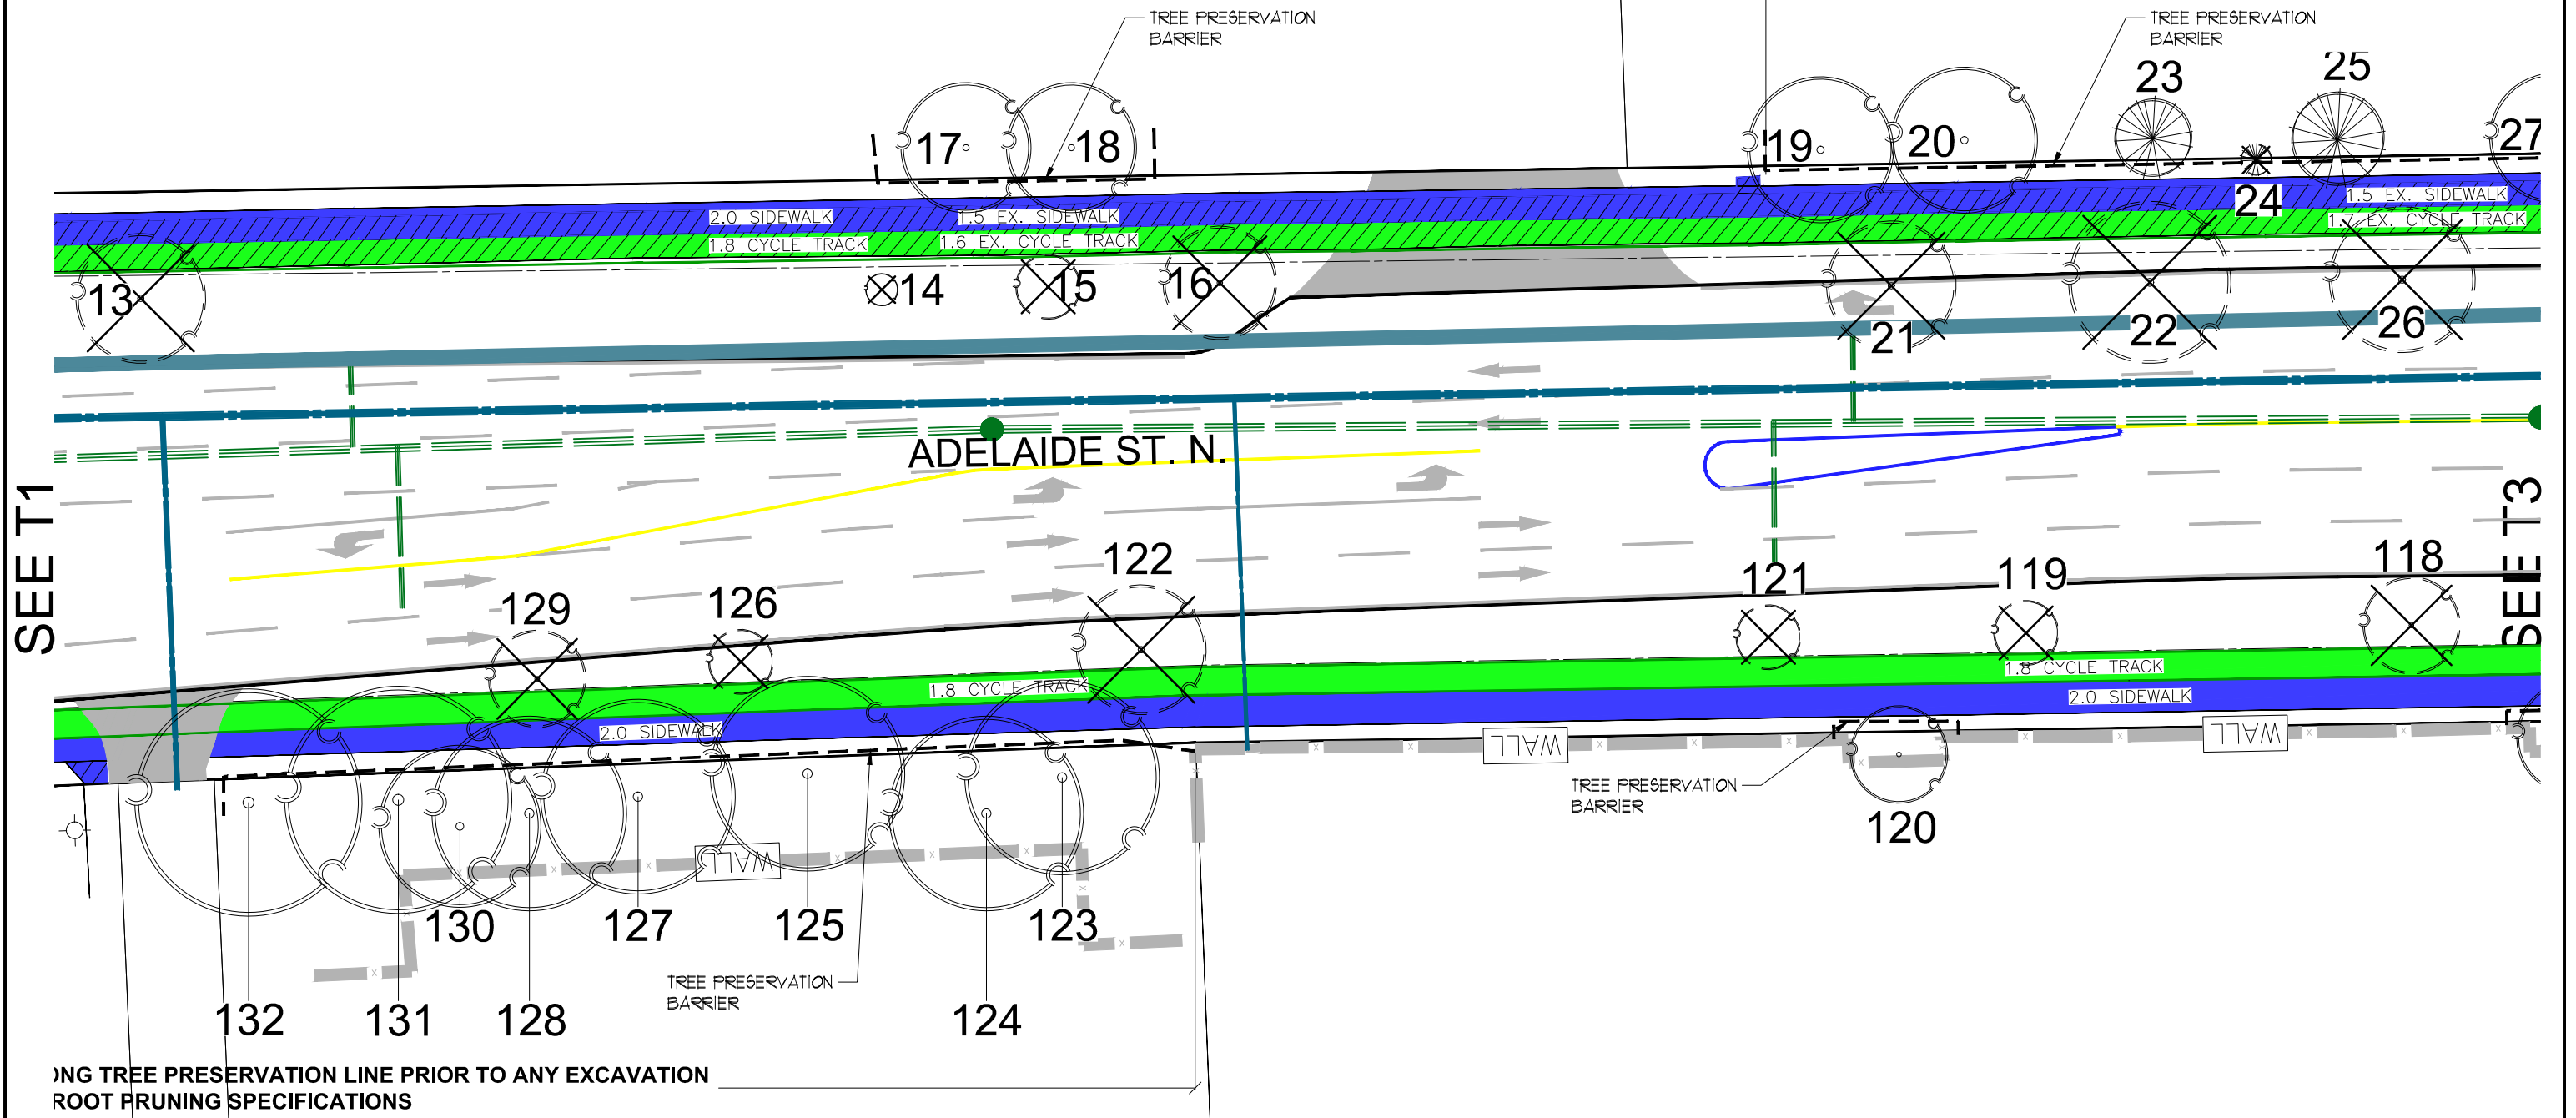
EXCAVATION FOR WATER MAIN INSTALLATION
WESTERN EDGE OF PROPOSED SIDEWALK TC

ING TREE PRESERVATION LINE PRIOR TO ANY EXCAVATION
ROOT PRUNING SPECIFICATIONS

1. stake out the line of tree preservation - as indicated by the tree preservation barrier.
2. using an air spade, cut a trench 6" - 10" wide and min. 18" deep.
3. exposed roots to be cleanly cut with a hand saw, chain saw, or bypass pruners.
4. cuts to be made parallel with the street along the tree preservation line. Root pruning perpendicular to the street is not required.
5. once all cuts are made, replace soil in the trench. 'root rescue' or a similar product with active mycorrhizal fungi to be incorporated into backfill as per manufacturer specifications. if additional soil is required, 2-way mix topsoil can also be incorporated into the backfill. backfilling to occur within same day as cuts are made.
6. trees to be watered within one day following root pruning - with water directed to the trench to settle large air pockets.

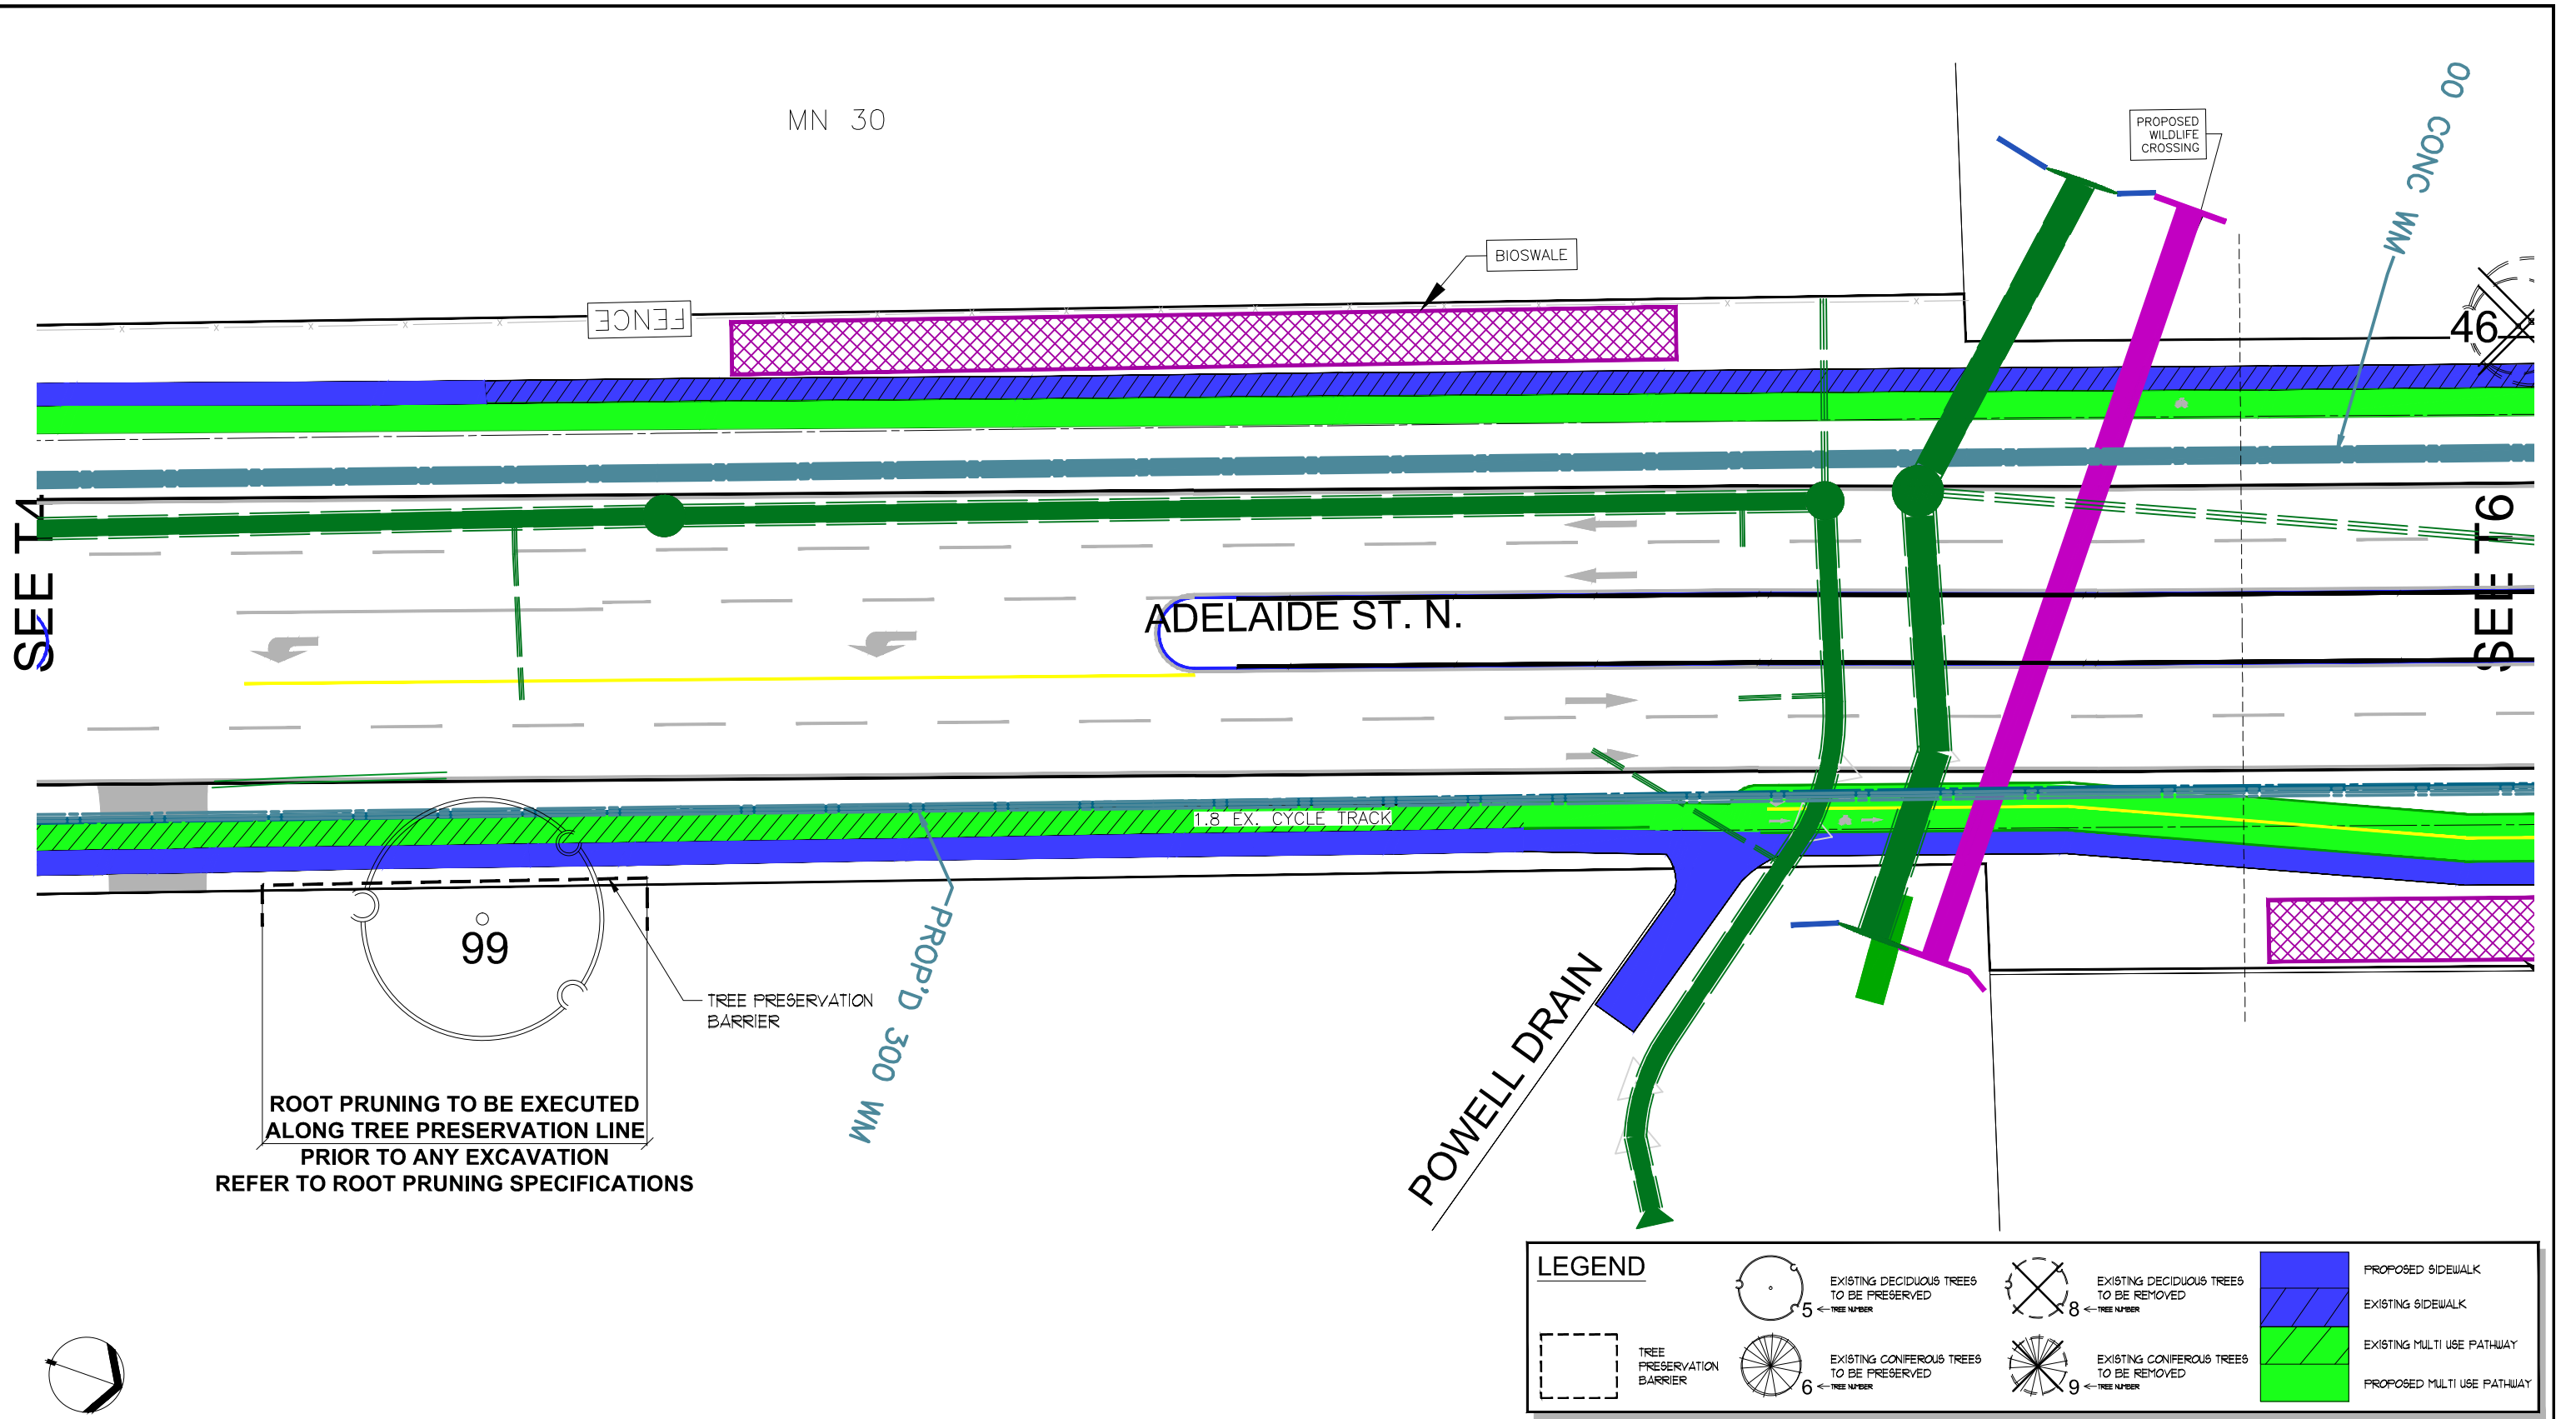
PROJECT NUMBER: 18-191Lg	SCALE: 1:400
DRAWN BY: RKLA Inc.	DATE: 2020.11.06
DRAWING NUMBER: T-5

ROOT PRUNING TO BE EXECUTED
ALONG TREE PRESERVATION LINE
PRIOR TO ANY EXCAVATION
REFER TO ROOT PRUNING SPECIFICATIONS

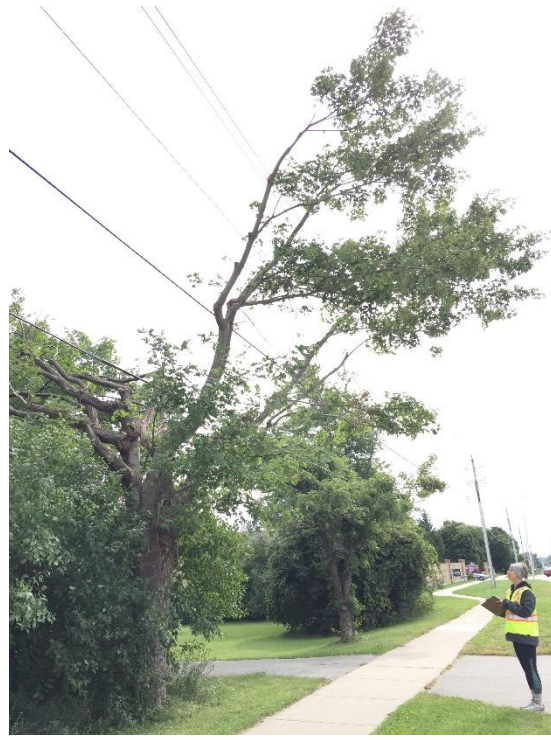
Tree # 87 – Freeman Maple
1825 Adelaide St. N

87	<i>Acer rubrum</i>	Freeman Maple	1845 Adelaide St N	14	2	5	POOR	bulbous roots, on slope Oct 22, 2019 notes: significant bark splitting and cracking along entire trunk	remove	conflict with proposed cycle track alignment	consent to remove from private property required
88	<i>Acer freemanii</i>	Freeman Maple	City ROW	51	5	4	POOR	boulevard tree, significant hydropruning on street side, no leader, major cavity	remove	direct conflict with cycle track and condition	N/A
89	<i>Acer freemanii</i>	Freeman Maple	City ROW	38	3	3	POOR	low union, co-dominant leaders, major cavity	remove	direct conflict with cycle track and condition	N/A
90	<i>Acer platanoides</i>	Norway Maple	1740 Adelaide St N	36	5	5	GOOD	wide flare, exposed roots, vertical scar on southwest side	preserve	Private property, no expected construction impacts	
91	<i>Acer platanoides</i>	Norway Maple	1740 Adelaide St N	36	4.5	5	FAIR	vertical scar on southwest side, exposed girdled roots	preserve	Private property, limited expected construction impacts

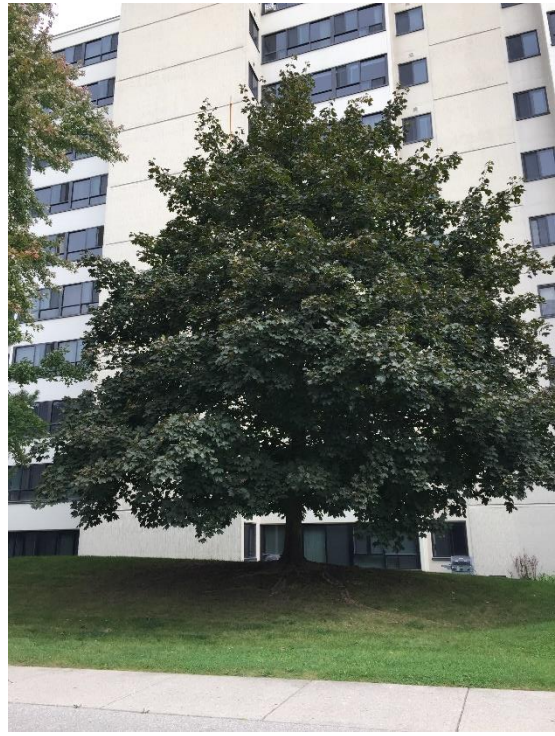
Tree # 112 – Red Maple
600 Adelaide St. N

112	<i>Acer rubrum</i>	Red Maple	BOUNDARY TREE - 600 Grenfell Dr & City ROW	53	6.5	5	FAIR	minimal root flare, exposed roots, uneven crown	preserve	Minor construction impacts expected	
113	<i>Acer platanoides</i>	Norway Maple	600 Grenfell Dr	32	6	5	GOOD	top of slope, exposed roots	preserve	Private property, minor construction impacts expected	
114	<i>Pinus nigra</i>	Austrian Pine	600 Grenfell Dr	35	5	5	GOOD	excellent	preserve	Private property, minor construction impacts expected	
115	<i>Acer saccharinum</i>	Silver Maple	600 Grenfell Dr	96	6.5	5	FAIR	poor form, exposed damaged roots	preserve	Private property, minor construction impacts expected	
116	<i>Pyrus spp</i>	Pear Tree	City ROW	15, 10, 5	2	5	FAIR	boulevard tree, multistem 3, suckers emerging from base	remove	conflict with road alignment and cycle track	N/A
117	<i>Acer platanoides 'Royal Red'</i>	Royal Red Norway Maple	601 Grenfell Dr	15	3.5	5	GOOD		preserve	Private property, minor construction impacts expected
