# 1494 Commissioners Road West, London, ON

## Tree Preservation Report

August 28, 2023

**MTE File No.:** 42446-200

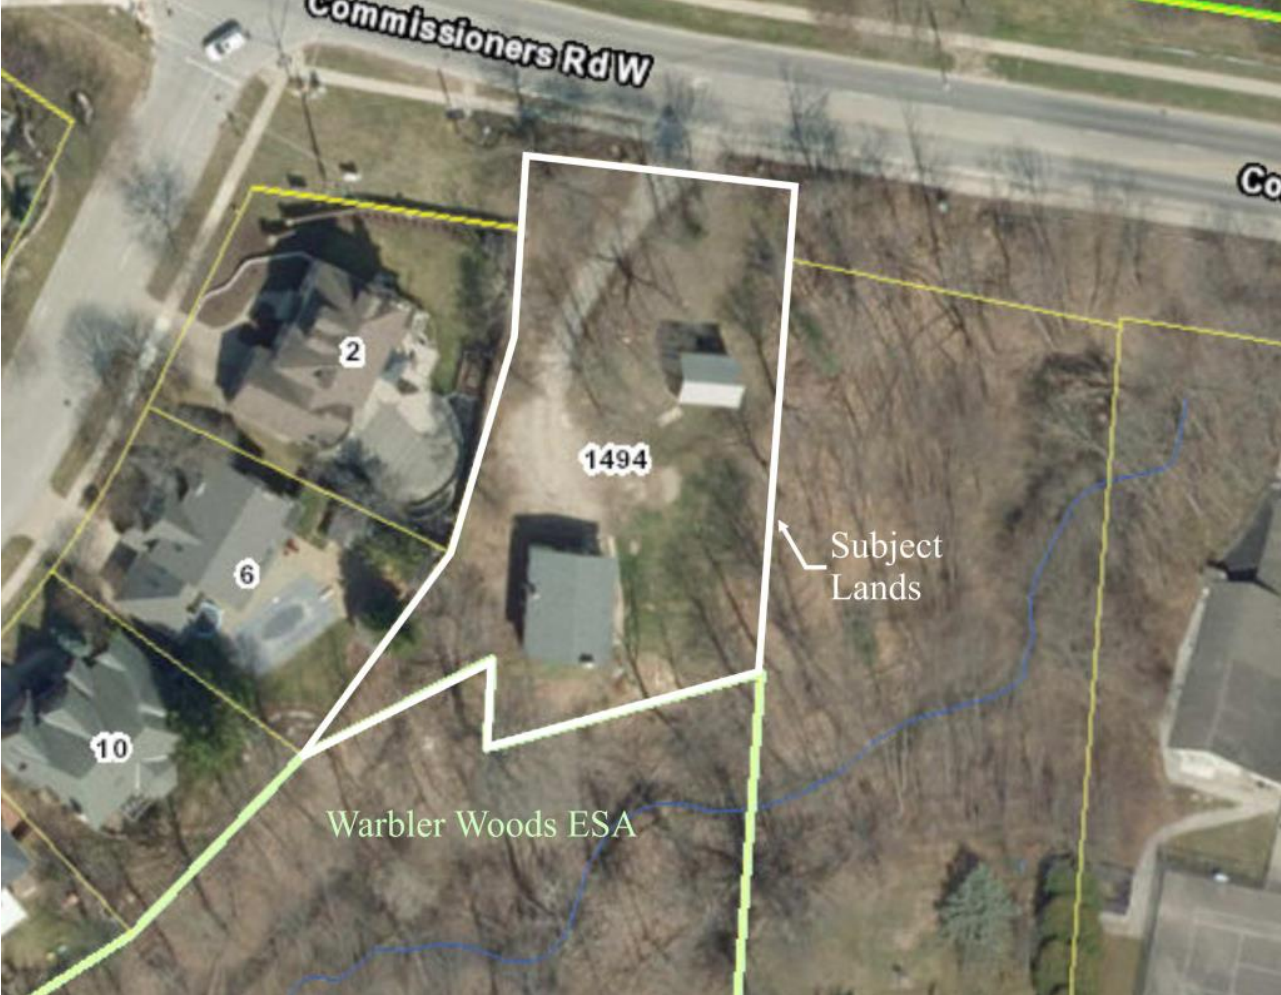
Figure 1.0 – Site Location

MTE Consultants Inc. (MTE) was retained by Maroun Moubarak to update the Tree Preservation Report to reflect a revised residential development proposal at 1494 Commissioners Road in London, ON [Figure 1]. The previous tree preservation report was prepared in 2012 by BioLogic.

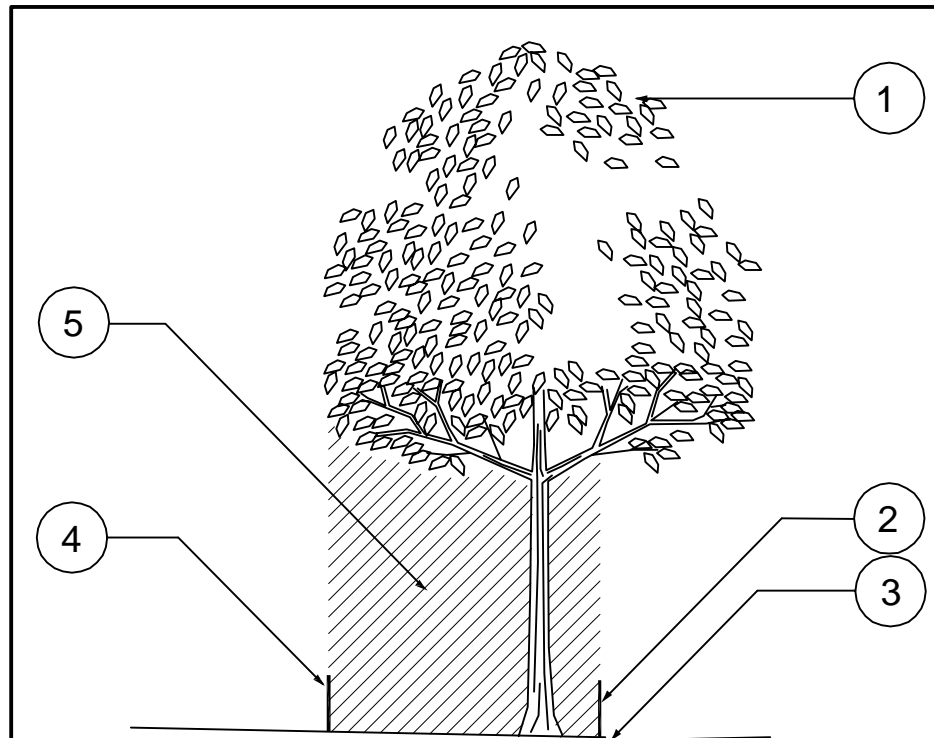
TREE PROTECTION BARRIER FENCING DETAIL

- SPECIFIC NOTES :**
- ① **EXISTING TREE TO BE PROTECTED :**
    - 1.1 This detail shall be used in conjunction with City of London Tree Protection specification TPP-7 and TPP-8 and OPSS 565.07.02

- ② **TREE PROTECTION FENCING MATERIAL :**
    - 2.1 Minimum 1.2m high orange vinyl snow fencing or other approved material supported by steel posts at a maximum 2.4m spacing.

- 2.2 Fencing material shall erected according to the approved Construction Drawing Tree Management Plans and approved by the Contract Administrator prior to the commencement of construction operations.

- ③ **TREE PROTECTION FENCING ON CURBSIDE :**
    - 3.1 Where the tree is flanked by a curb the barrier placement shall be to the furthest extent of the boulevard area as approved by the Contract Administrator.

- ④ **TREE PROTECTION FENCING :**
    - 4.1 Where space accommodates, tree protection fencing shall be placed at the dripline of the trees to be preserved.

- 4.2 Dripline is defined as the location on the ground surface directly beneath a theoretical line defined by the tips of the outermost branches of the trees.

- ⑤ **TREE PROTECTION BARRIER ZONE :**
    - 5.1 No construction equipment shall enter the tree protection barrier zone.
    - 5.2 No construction materials shall be piled or stored within the tree protection barrier zone.
