# Interim Asset Management Strategy: Arva Pumping Station to Huron Street Water Transmission Main Municipal Class Environmental Assessment Master Plan London, Ontario

**Date:** October 2020

**Project #:** 60619503

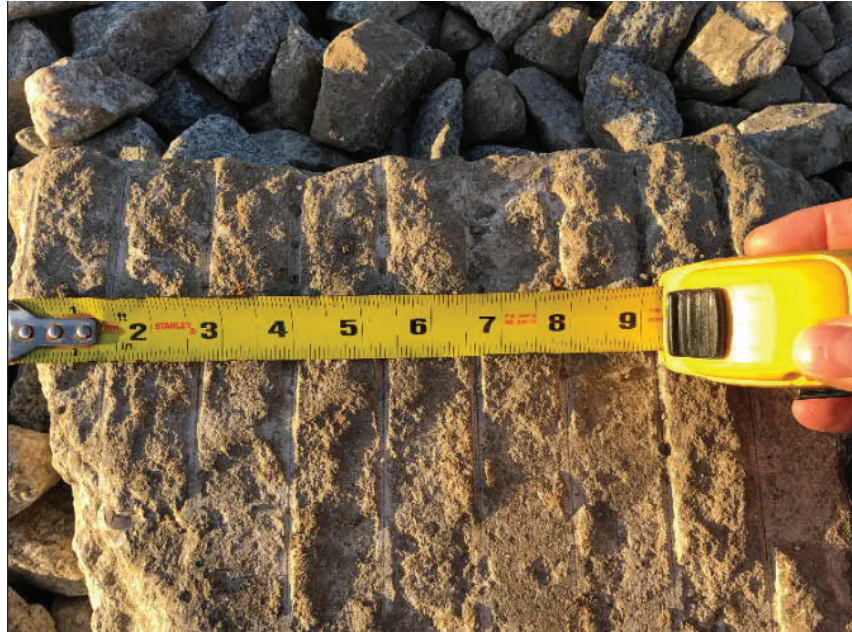
Figure 2: Underside of Mortar Coating from PCCP, Revealing Wire Diameter and Spacing.

- Basic dimensional properties including cylinder thickness, prestress wire diameter and spacing, inner and outer concrete core thickness, and mortar coating thickness (Figure 2).

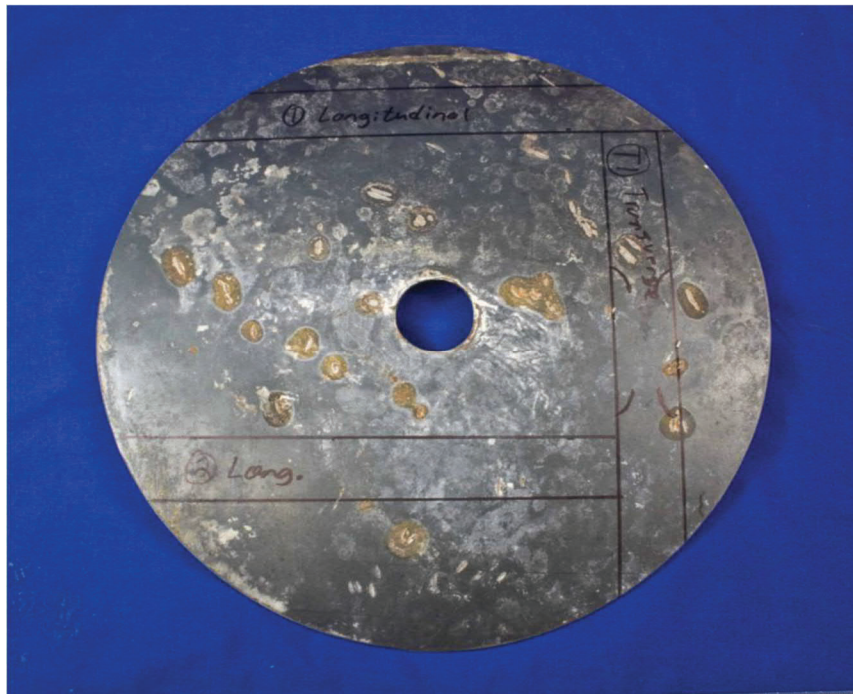
Figure 3: Tensile Specimen Locations in Steel Cylinder (note weld along top of coupon)

- Tensile strength testing of the steel pipe cylinder in accordance with ASTM A370<sup>1</sup> - Annex 2. Multiple test specimens should be taken at different orientations in the cylinder because tensile strength may vary with direction due to the rolling process used to manufacture the steel (Figure 3).

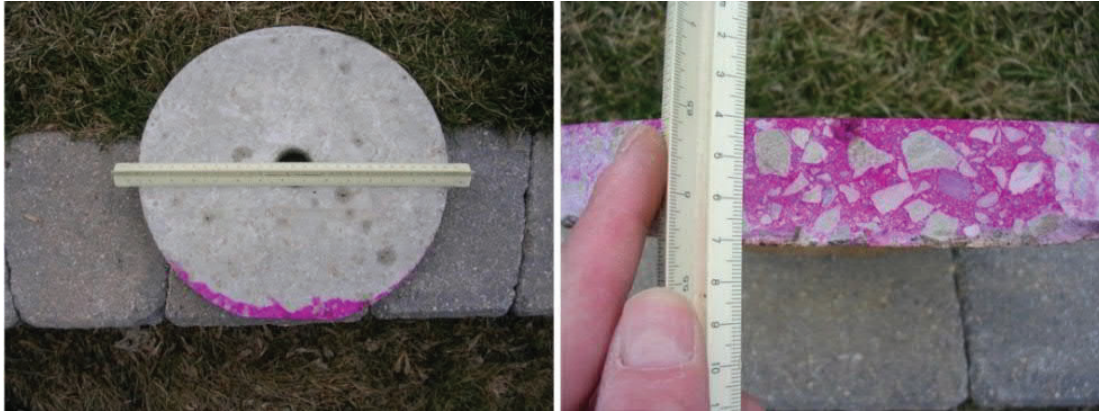
**Figure 4: Cement Degradation (pH) Test of Concrete Pipe Core.**

- Cement degradation testing by application of pH indicator (Figure 4).
- Petrographic analysis of the mortar coating and core concrete to evaluate quality of manufacture, presence of protective chemicals or treatments, and extents of chemical and mechanical deterioration.

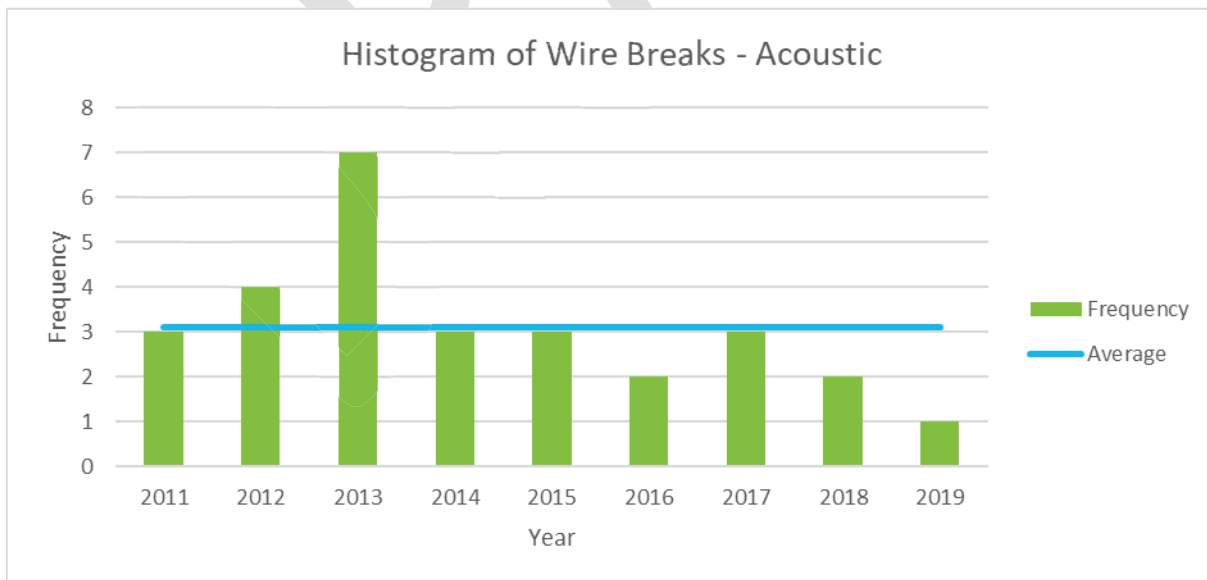
**Figure 7: Histogram of Wire Breaks – Acoustic Sensors**

In the “AFO Wire Breaks” worksheet, there were 28 reported wire breaks in 23 pipes. The records of the frequency commenced in 2011 (baseline of wire breaks) until 2019. As the total wire breaks exceeded the number of pipes, some pipes experienced more than one break during the monitoring period (2011-2019). Figure 7 shows a histogram of the wire breaks occurrence from 2011 to 2019. As per the figure, most of the wire breaks occurred in 2013 (seven wire breaks). Roughly and on average, three wire breaks occurred in a year. Figure 8 shows the frequency of the wire breaks per Pipe ID. Most of the identified pipes experienced one wire break from 2011 to 2019; however, four wire breaks from 2012 to 2015 were detected in Pipe 11-182 (one wire break a year).

Figure 7 shows the wire breaks detected by AFO in each year. According to Figure 7, 14 different pipe sections experienced at least one wire break during 2011 and 2013. It was expected that wire break information for the pipes reported for the PipeDiver inspection in 2014 (assuming that EM inspection was conducted where AFO is installed) would be included. However, this information is not found in the "Pipe Chart" worksheet. Furthermore, the same two pipes (11-170A and 11-172) were removed in December 2017, where the mortar was removed on both pipes. Also, pipe specification measurements of the exposed prestressing wire were taken and Pure conducted continuity tests. However, this event is not identified in the "Pipe Chart" worksheet. Following the removal of the mortar, to expose the prestressing wires, 16 broken wires were observed in 11-170A and 21 broken wires observed in 11-172. Pure conducted previous investigations of inspected PCCP within the City and determined a Suitable Yield Limit to be 25 broken wire wraps. This is consistent with the average of Pure's EM/AFO database with PCCP confirmed with similar characteristics. It is important to note that this investigation/review is not representative of a structural analysis. The original PipeDiver and external scanning results were reviewed against wire measurements collected by Pure to confirm the calibration curve used to quantify the quantity of broken wire wraps.
