TREE PRESERVATION REPORT FOR ZONING BY-LAW AMENDMENT

**300-306 PRINCESS AVE
LONDON, ONTARIO**

Report prepared by
Ron Koudys Landscape Architects Inc

RKLA Project #23-228

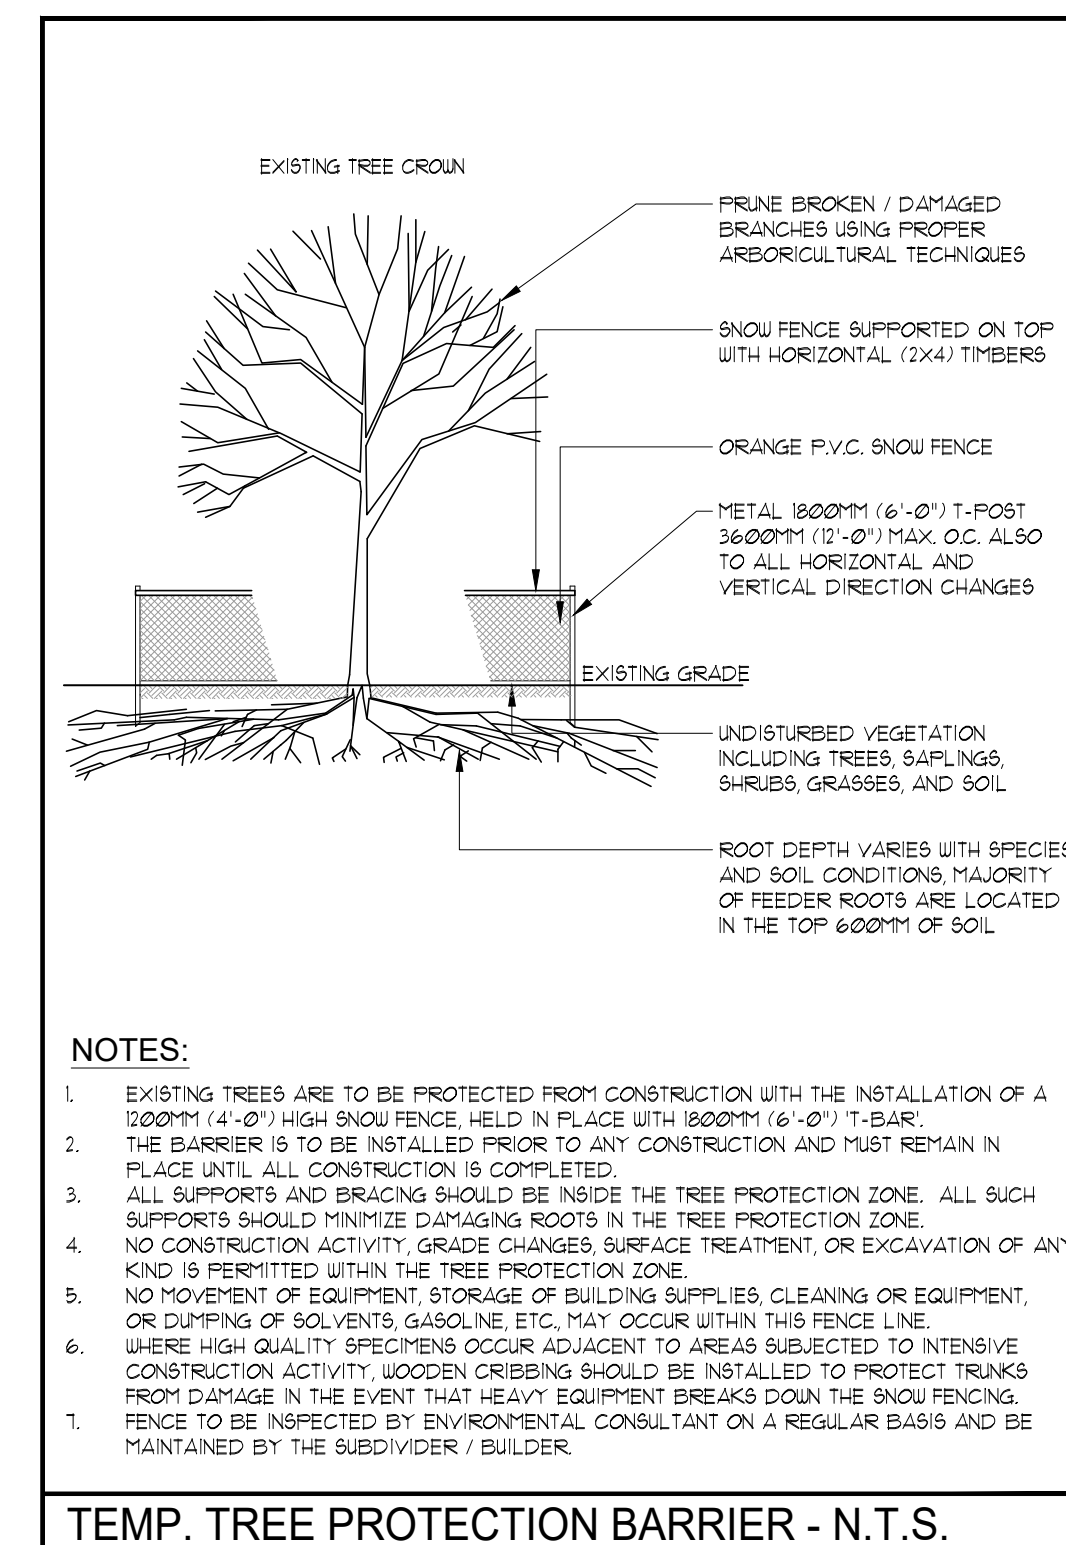
DRAWING TITLE:
TREE PRESERVATION PLAN

ID #	GENERAL INFORMATION			SIZE			HEALTH & CONDITION		RECOMMENDATIONS			
	BOTANICAL NAME	COMMON NAME	LOCATION	DBH (cm)	CANOPY RADIIUS (m)	CROWN CONDITION	STRUCTURAL FORM	STRUCTURAL INTEGRITY	COMMENTS	EXPECTED CONSTRUCTION IMPACTS	PRESERVE OR REMOVE	IMPACT MITIGATION or REMOVAL RATIONALE
1	<i>Quercus rubra</i>	Red Oak	City ROW Princess Ave	6	15	5	good	good	Slight lean west	no expected impacts	preserve	tree protection barrier
3	<i>Platanus x acerifolia</i>	London Plane Tree	City ROW Princess Ave	14	25	5	good	good	Minor basal wound	no expected impacts	preserve	tree protection barrier
8	<i>Ailanthus altissima</i>	Tree of Heaven	City ROW Princess Ave	18, 10	2	4	fair	fair	Primary union at grade	no expected impacts	preserve	N/A
9	<i>Acer platanoides</i>	Norway Maple	308 Princess Ave (subject site)	40	4	3	poor	fair	Bark slough, large weeping wound	no expected impacts	preserve	N/A
10	<i>Acer saccharinum</i>	Gulfed Silver Maple	308 Princess Ave (subject site)	59	3	3	poor	fair	Weeping wounds, cavities forming	no expected impacts	preserve	tree protection barrier

- EXISTING TREES ARE TO BE PROTECTED FROM CONSTRUCTION WITH THE INSTALLATION OF A 1000MM (4'-0") HIGH SNOW FENCE HELD IN PLACE WITH 800MM (6'-0") T-BEAR.
