PROJECT TITLE:  
**YORK DEVELOPMENT**  
 50 KING STREET  
 LONDON, ONTARIO

DRAWING TITLE:  
**TREE PRESERVATION PLAN**

DATE: SEPT. 2022	SCALE: AS NOTED	DRAWING No. <b>T-1</b>
DRAWN: RKL/A Inc.	CHECKED BY: B.R.M.	
PROJECT No. 21-293LJ

DRAWING TITLE:  
**LANDSCAPE PLAN**

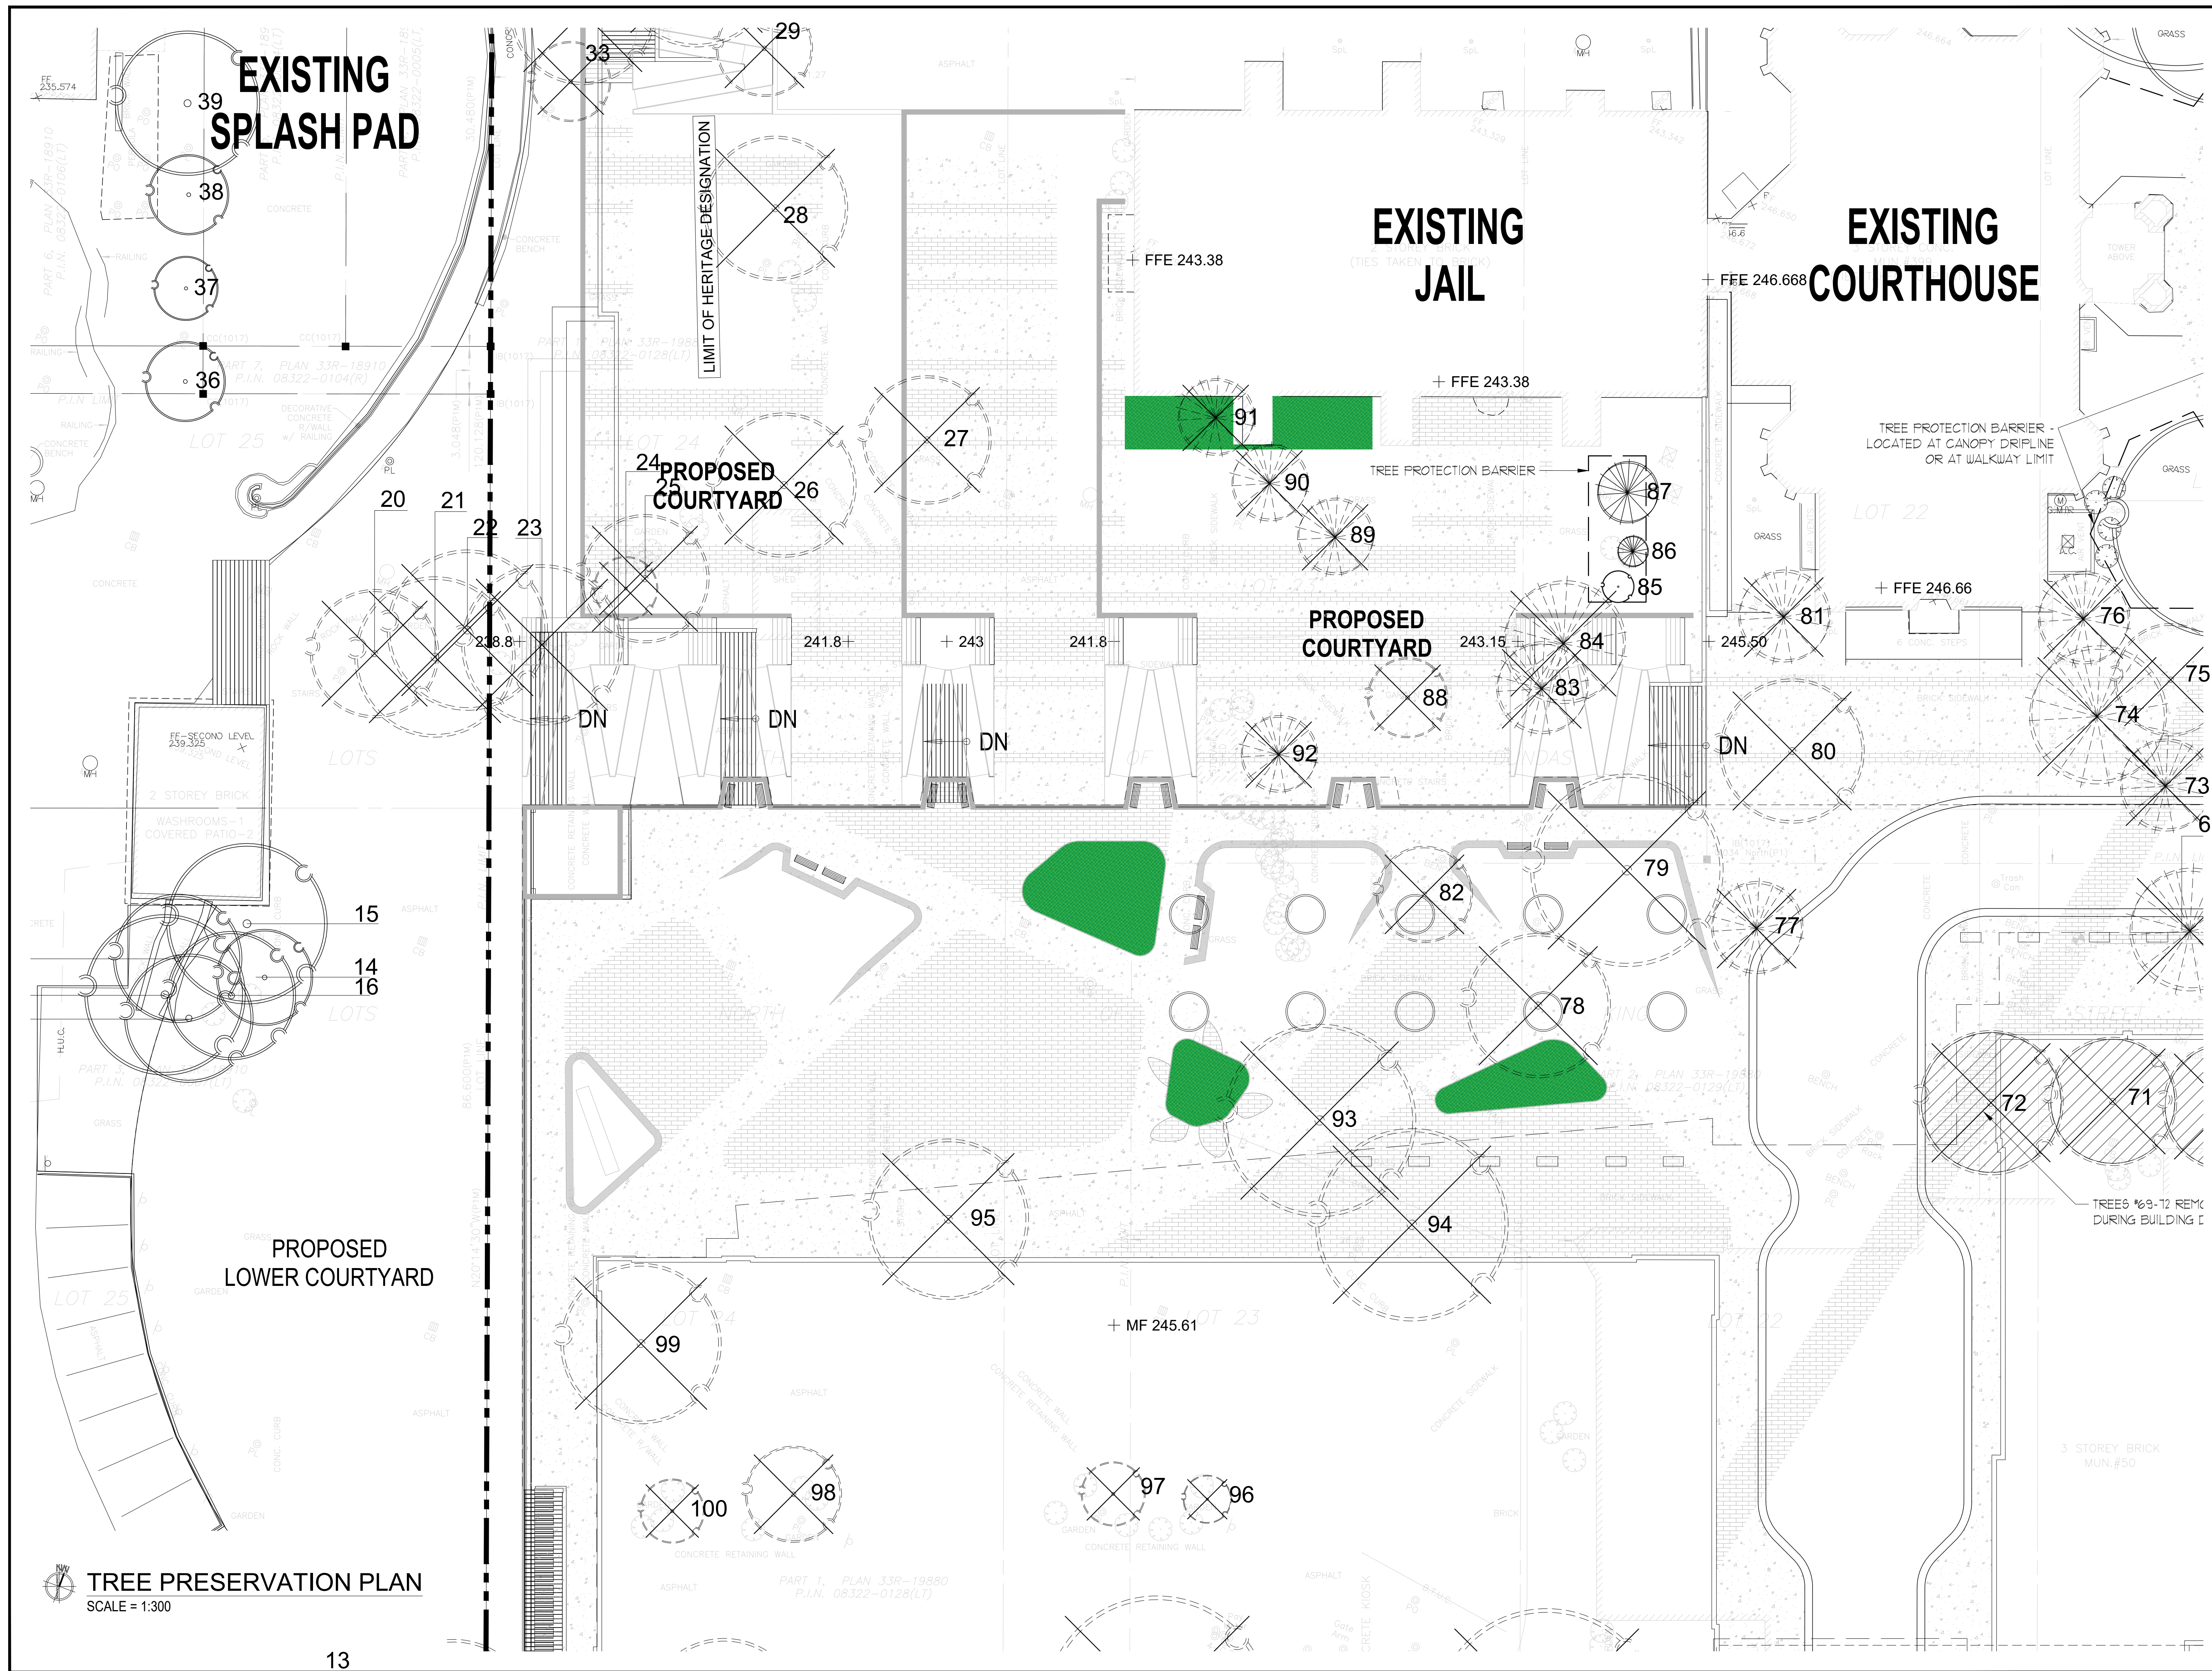
**TREE PRESERVATION PLAN**  
 SCALE = 1:300

TREES TO BE REMOVED

TREES TO BE PRESERVED

REFER TO TREE ASSESSMENT REPORT FOR MORE INFORMATION
